Implementation of Measures to Prevent Objects Falling off Airplanes

January 2018

Civil Aviation Bureau of Japan,
Ministry of Land, Infrastructure, Transport and Tourism
Association of Air Transport Engineering and Research

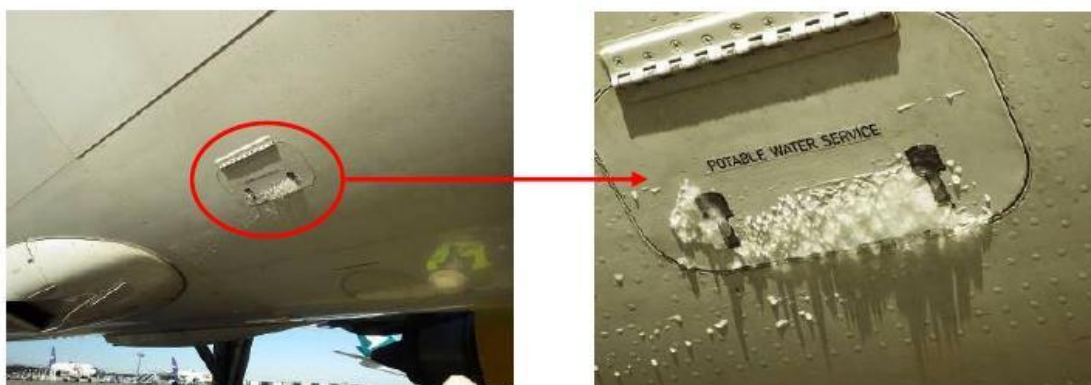
If the panel is not closed correctly or draining is insufficient after potable water servicing, ice blocks may form on the service panel and around it due to water leaks during flight. It is important to ensure that excess water is discharged after servicing, and it is also important, in particular, to completely drain water from the fill fitting itself. (Figure 3-1: Example of ice accumulation on potable water service panel and Figure 3-2: Example of ice accumulation on fill fitting (Potable water service panel))

Figure 3-1: Example of ice accumulation on potable water service panel

If a regular inspection task includes cleaning of the drain valve to maintain its functions properly and even a little water leak is found in daily water service, it is important to suspect if there may be a valve failure and immediately report it or inform the mechanics in charge of the aircraft.

Also, with regards to lavatory waste system, it is effective to confirm that no water is leaking from around the waste tank service panel and the cap is put properly. In addition, it is also effective to wipe off remaining moisture after cleaning the service panels and doors to prevent ice accumulation.

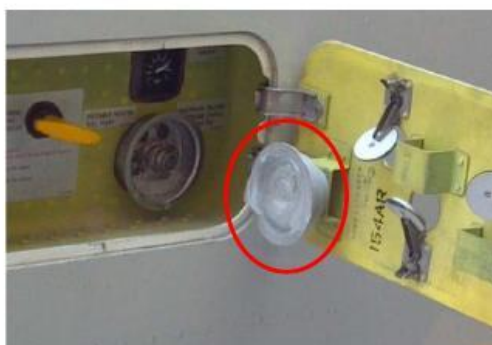
Figure 3-2: Example of ice accumulation on fill fitting (Potable water service panel)

A potable water drain is equipped to discharge water from the potable water system during maintenance work. However, improper switching of an internal valve or failure of an internal valve itself may cause a water leak into the drain line from the potable water system and may possibly result in ice accumulation.

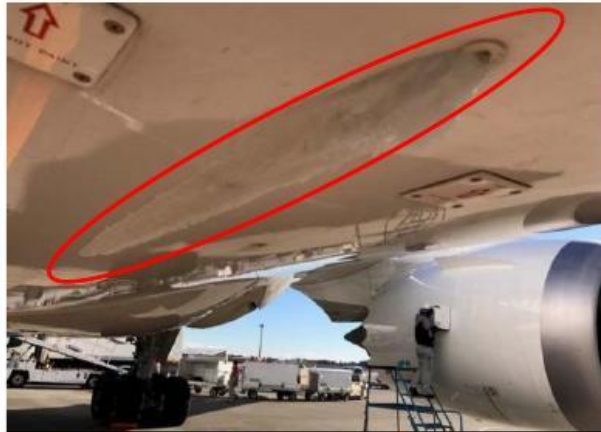
There are two conceivable mechanisms by which ice blocks form: One is that a drain valve has not been closed properly due to a temporary failure or dust clogging and this results in a water leak during flight; the other is that, when the difference in pressure between the inside and outside of the aircraft declines below certain altitude, the drain valve opens and the leaking water is exposed to the outside cold air. (Figure 3-3: Example of ice accumulation on fuselage drain)

Figure 3-3: Example of ice accumulation on fuselage drain

The drain valves of all models are required to be inspected and cleaned in periodical maintenance. Therefore, it is imperative that the function of these valves be maintained properly in order to prevent water from leaking to the outside of an aircraft during flight so that ice accumulation can be reduced. In addition, it is necessary to follow basic standards such as ensuring the complete removal of accumulated snow on cargo in order to prevent moisture from entering the cargo compartment. Further, it is important to follow the recommendations about ice accumulation on the cargo door as described in the next section.

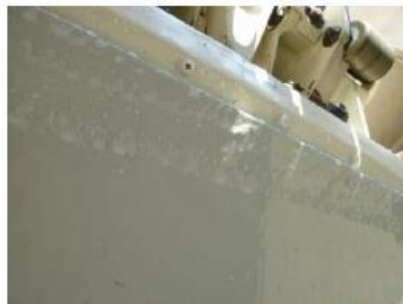
Ice accumulation on the cargo door may be caused by water leak or snow accumulation on cargo. It is important to remove moisture completely from the cargo and wrap it properly before loading. Take note of the following points:

Figure 3-4: Example of ice accumulation along the edge of the lower part of cargo door

- a. Make sure that cargo that has a potential for water leaks has been appropriately packed and wrapped in a way that it is judged to be robust enough for air transportation.
- b. When cargo is temporarily stored outdoors, appropriate measures shall be taken to prevent damage caused by rain and snow.
- c. Any snow and ice remaining on the cargo or unit loading device shall be removed before loading cargo on the aircraft.
- d. When containers and baggage are loaded in the cargo compartment, rainwater and snow on them shall be removed before they are carried in.
- e. If it is stormy when cargo is loaded and there is a possibility that a large amount of rainwater has got inside, be very careful.

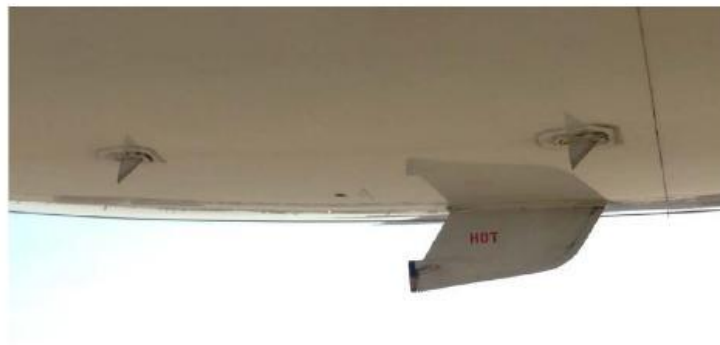
Figure 3-5: Drain mast

A drain mast is installed to discharge water from the galley and lavatory wash-basins. It is always heated during flight and controlled to prevent water from freezing. A failure of this heating function may cause ice blocks to form. It is important to confirm that the heating function of these areas works properly at the time of maintenance.

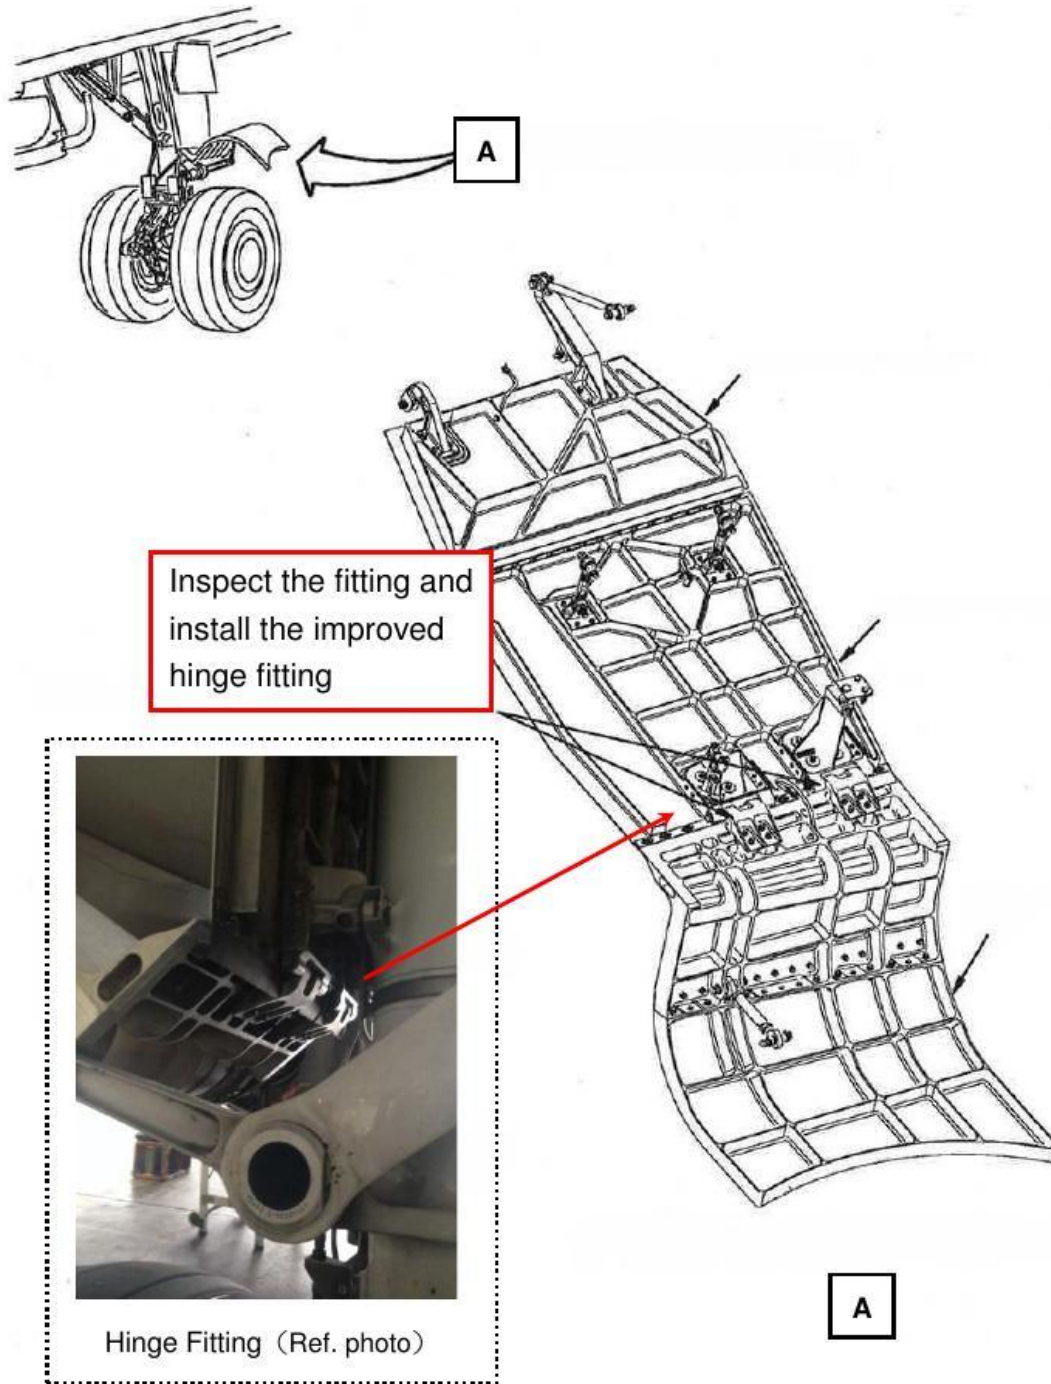
Fig. 1-1

Model	Title
B737	DOORS – Landing Gear Doors – Inboard Main Landing Gear Door Hinge Fittings – Inspection and Replacement (SB 737-52A-1167)

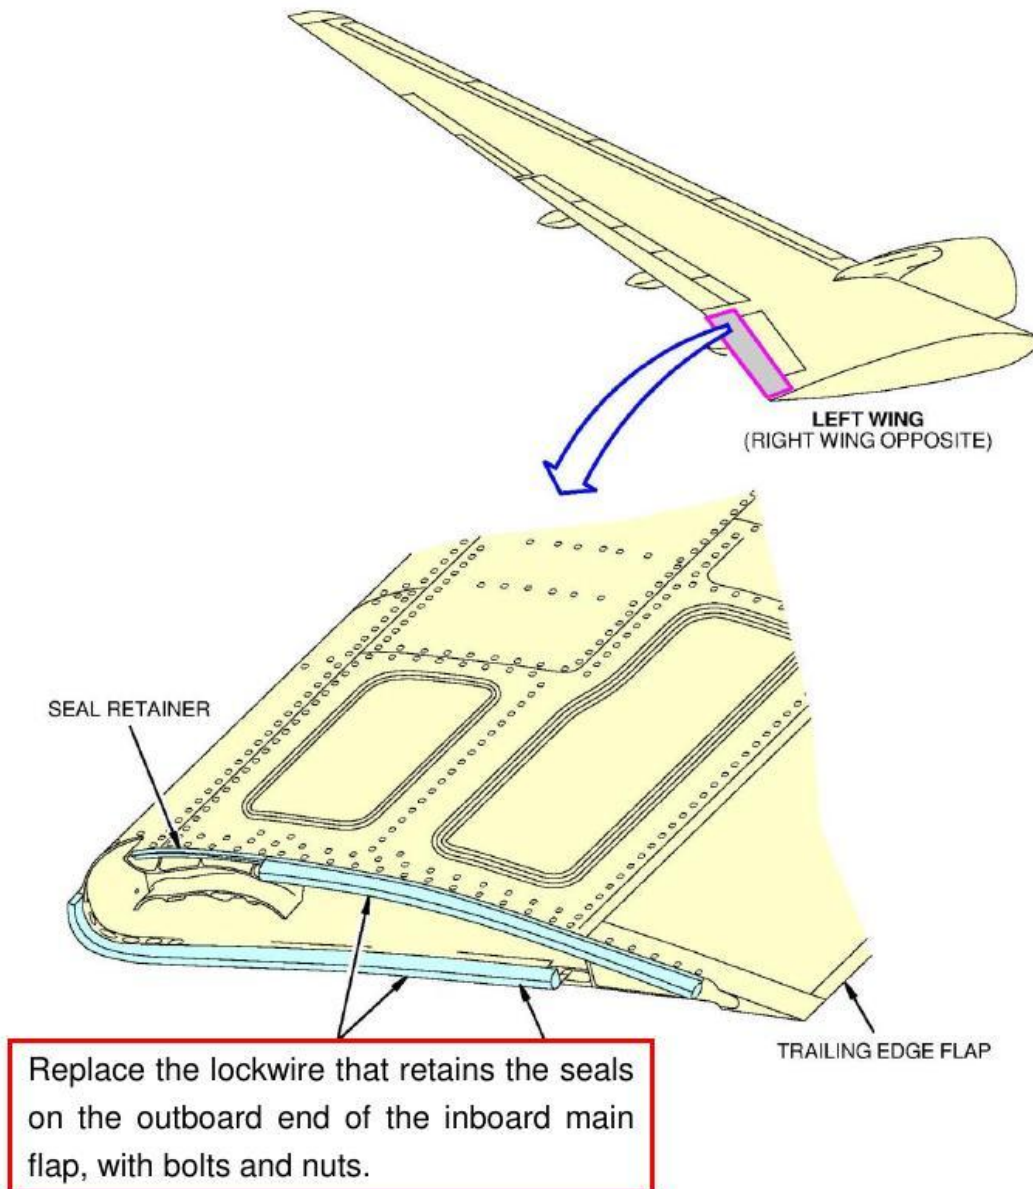
Fig. 1-2

Model	Title
B737	WINGS – Trailing Edge Flaps – Inboard Main Flap Seal Fastener Change (SB 737-57-1331)

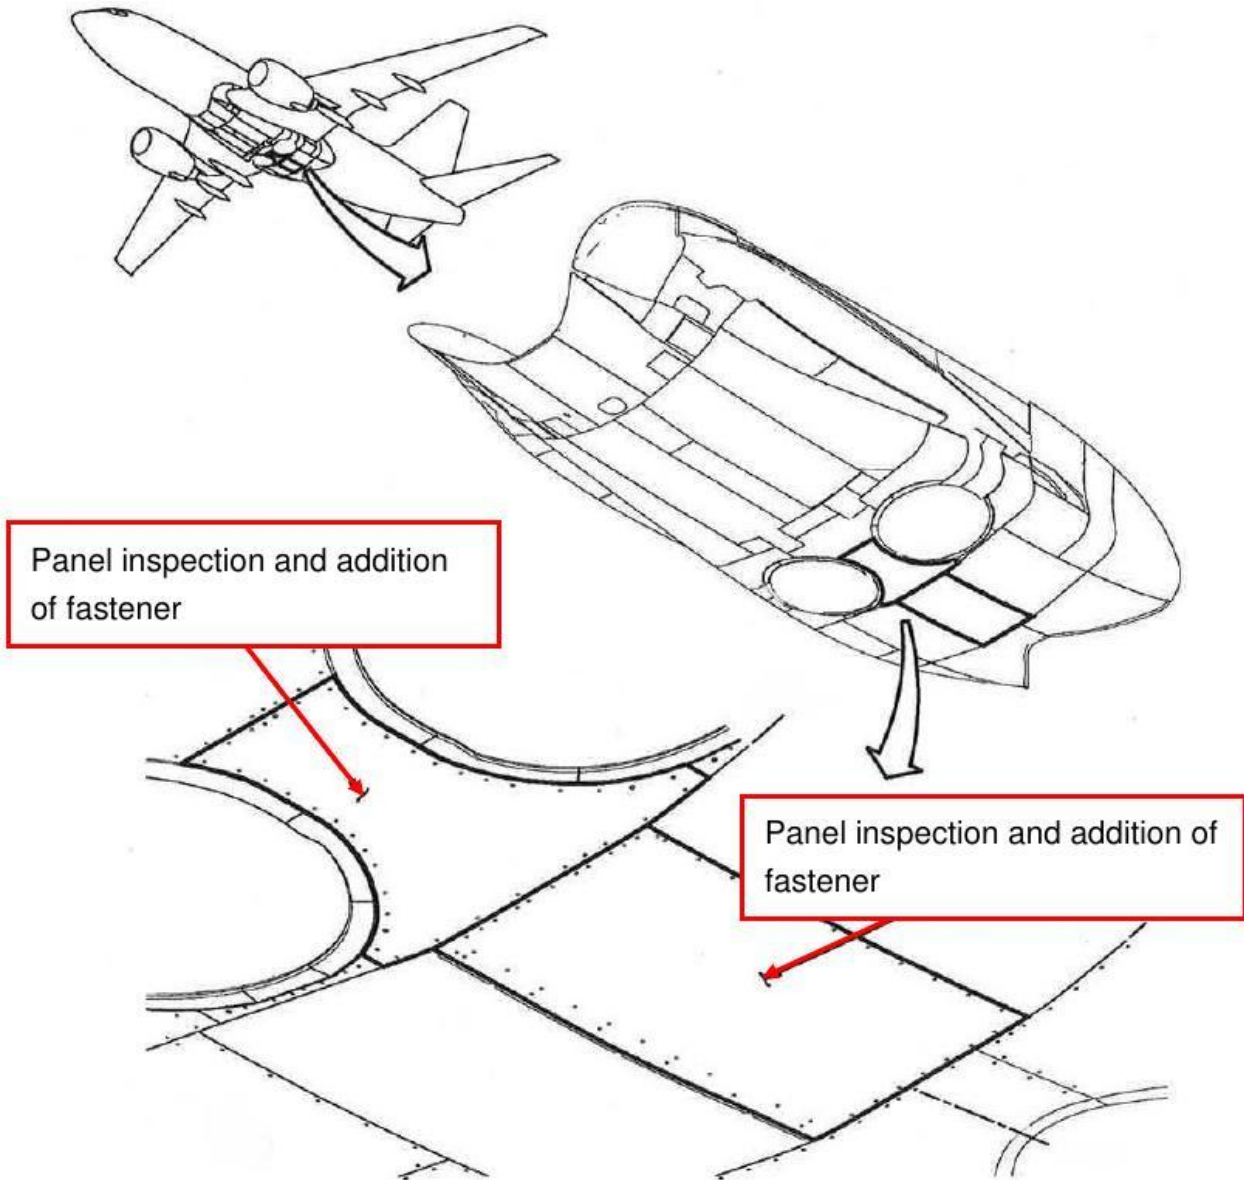
Fig. 1-3

Model	Title
B737	FUSELAGE – Fillet Fairings – Aft Wing to Body Fairing – Panel 194E and Aft Center Wheel Well Panel 193D – Inspection and Rework (SB 737-53-1307)

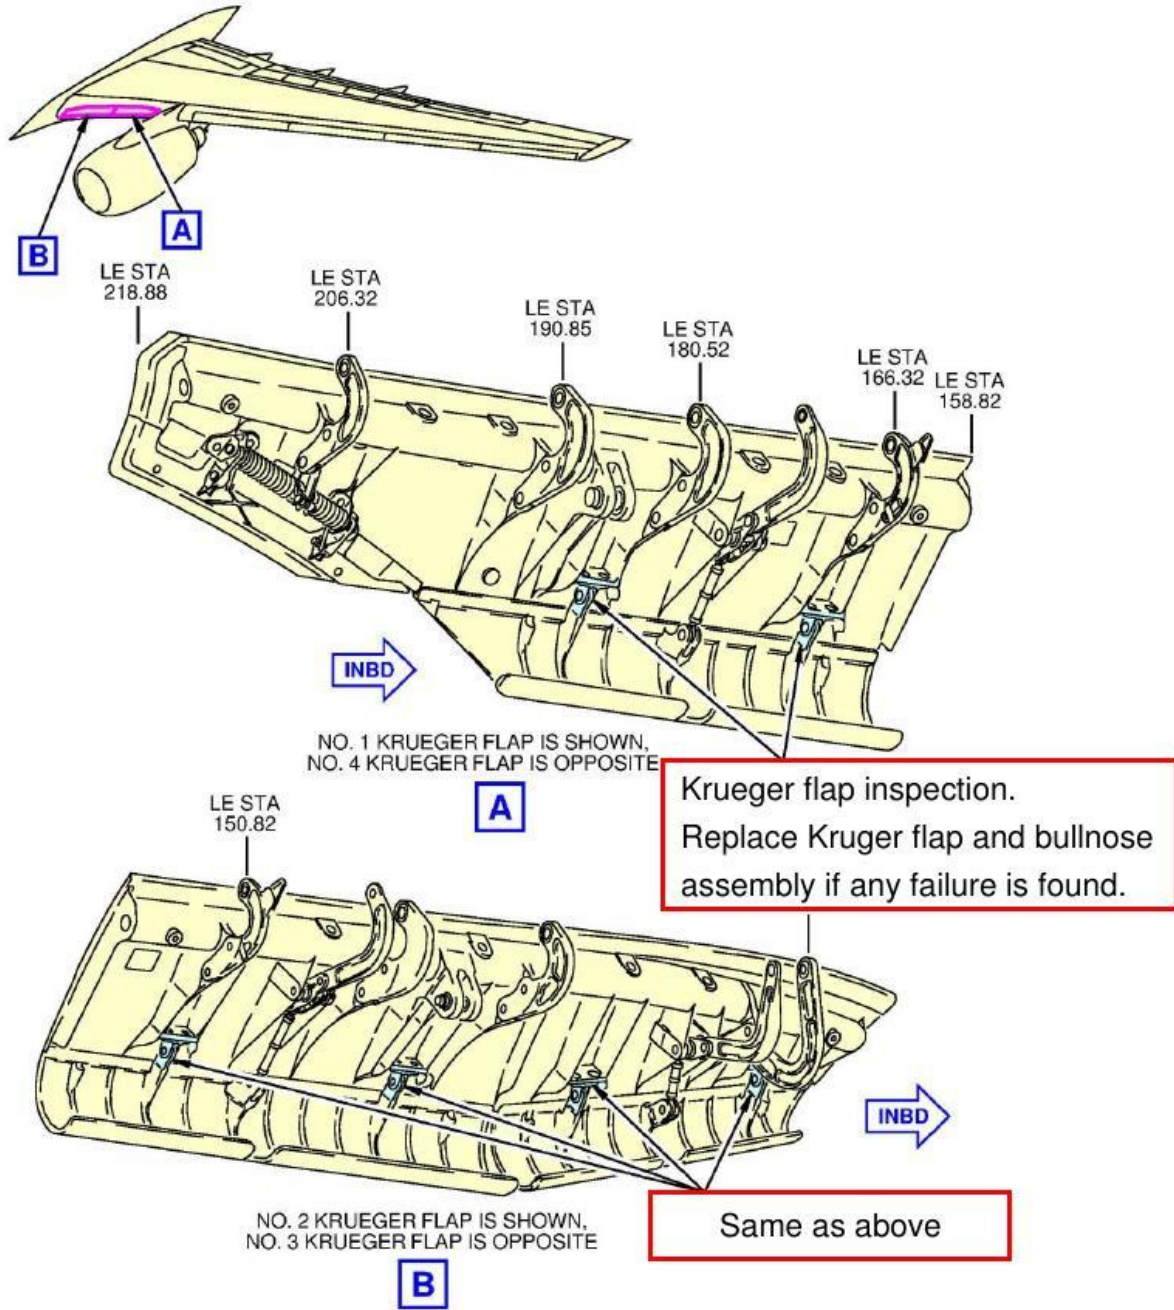
Fig. 1-4

Model	Title
B737	WINGS – Leading Edge And Leading Edge Devices – Krueger Flap Inspection (SB 737-57A-1327)

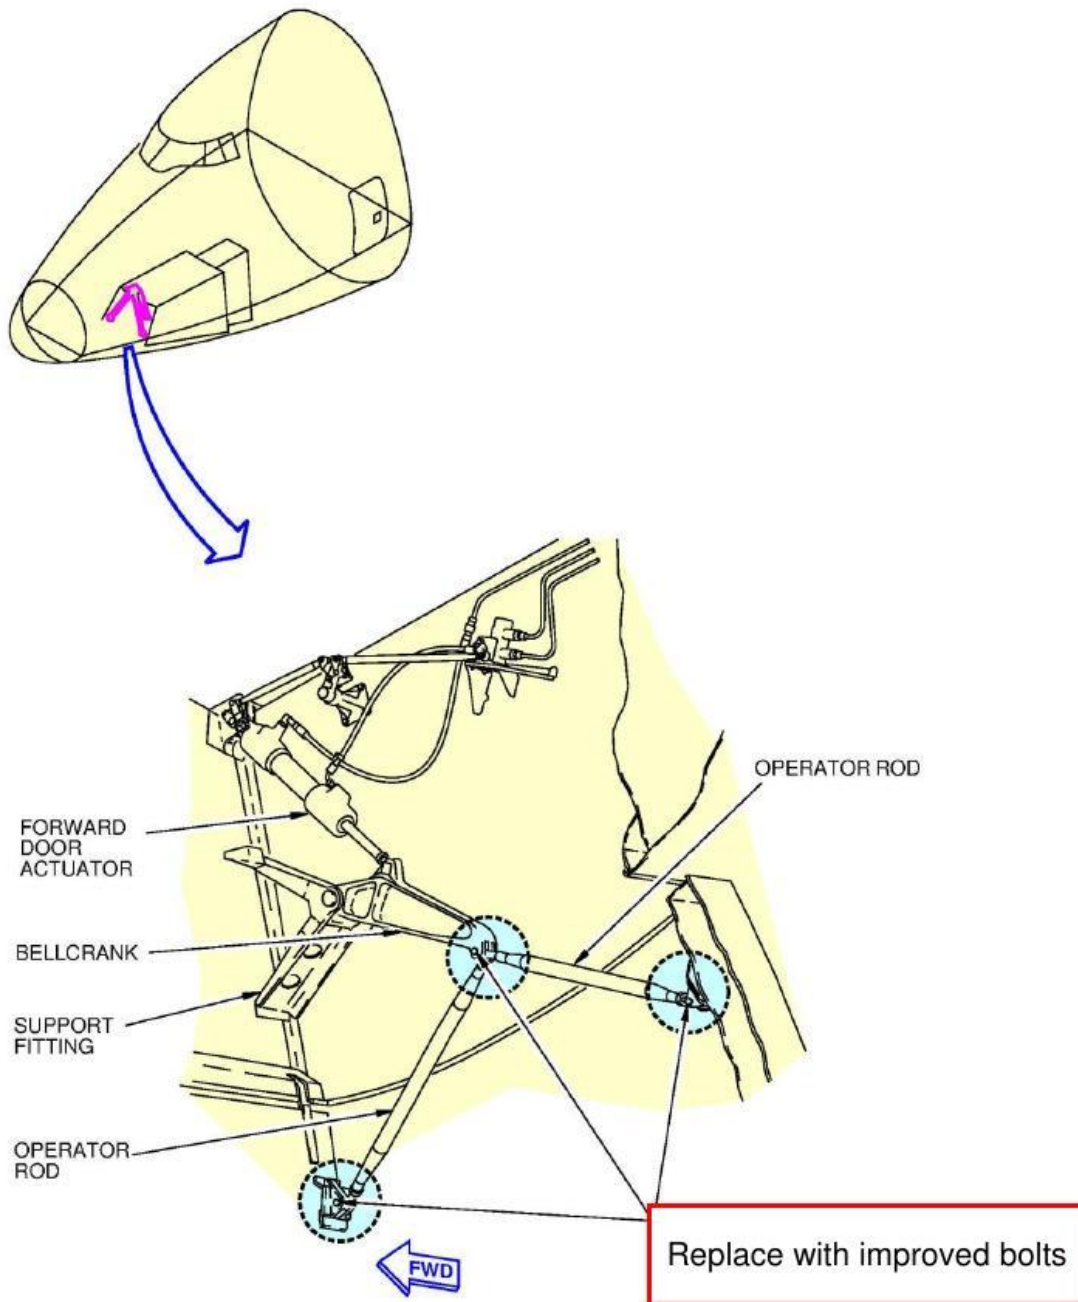
Fig. 1-5

Model	Contents of Measure
B747	FUSELAGE – Wheel Wells – Nose Landing Gear Forward Door Operator Rod Bolt Replacement (SB 747-53-2894)

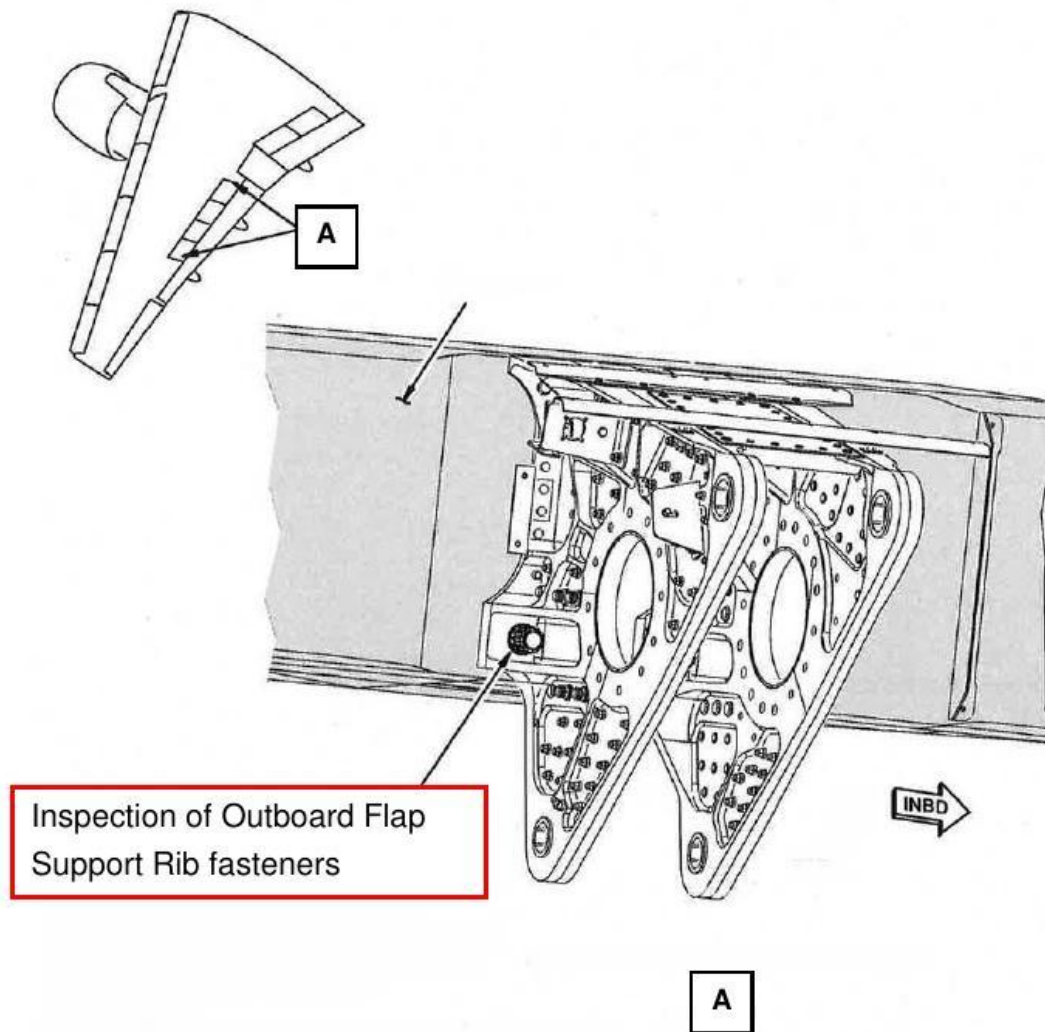
Fig. 1-6

Model	Title
B767	WINGS – Trailing Edge and Trailing Edge Devices – Outboard Flap Support Rib Nut Fracture Inspection (SB 767-57A-0131)

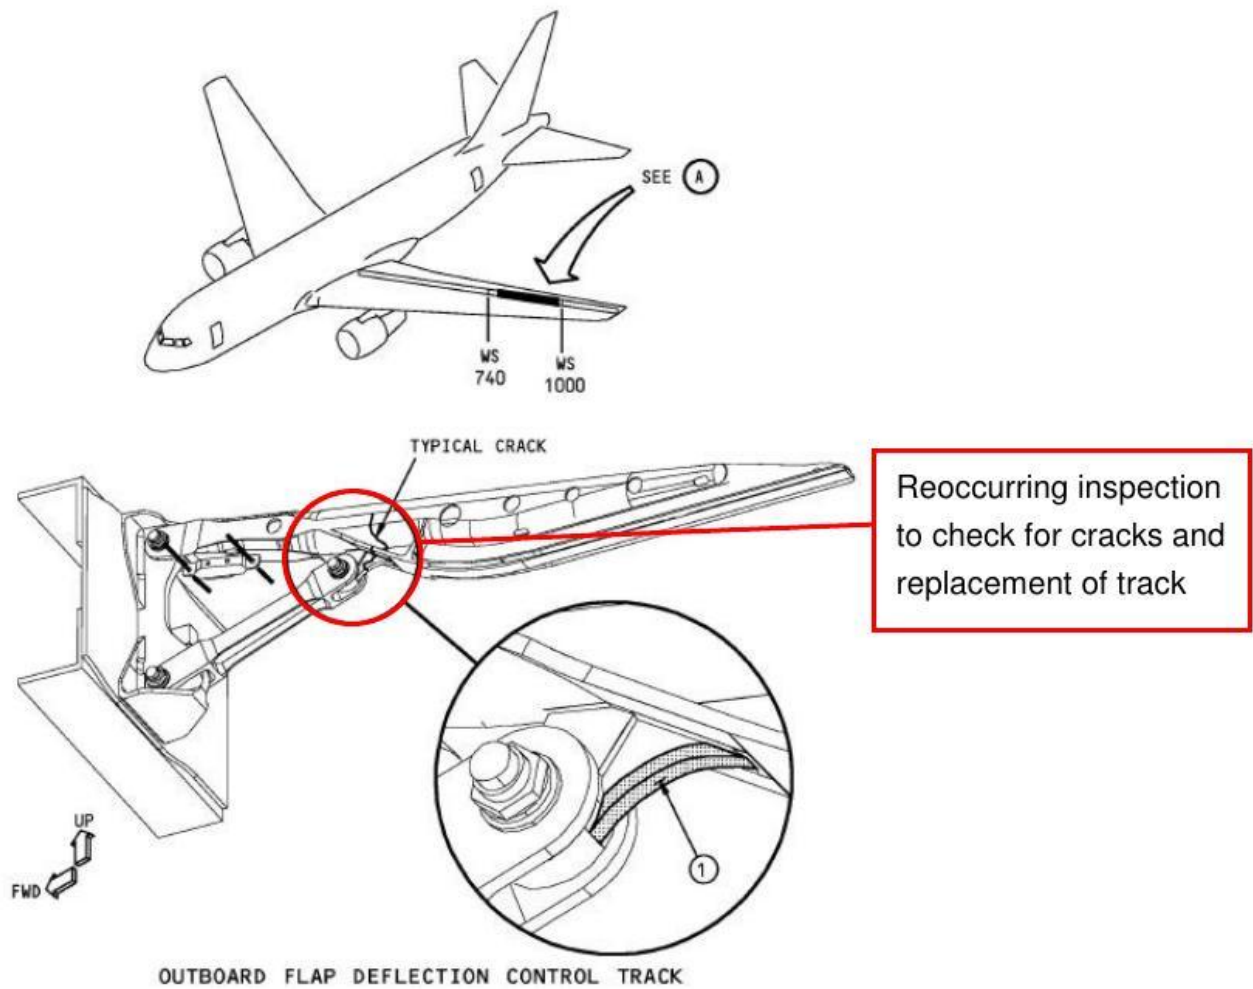
Fig. 1-7

Model	Title
B767	FLIGHT CONTROLS - Flaps - Outboard Flap Deflection Control Track -Inspection/Replacement (SB 767-27-0184)

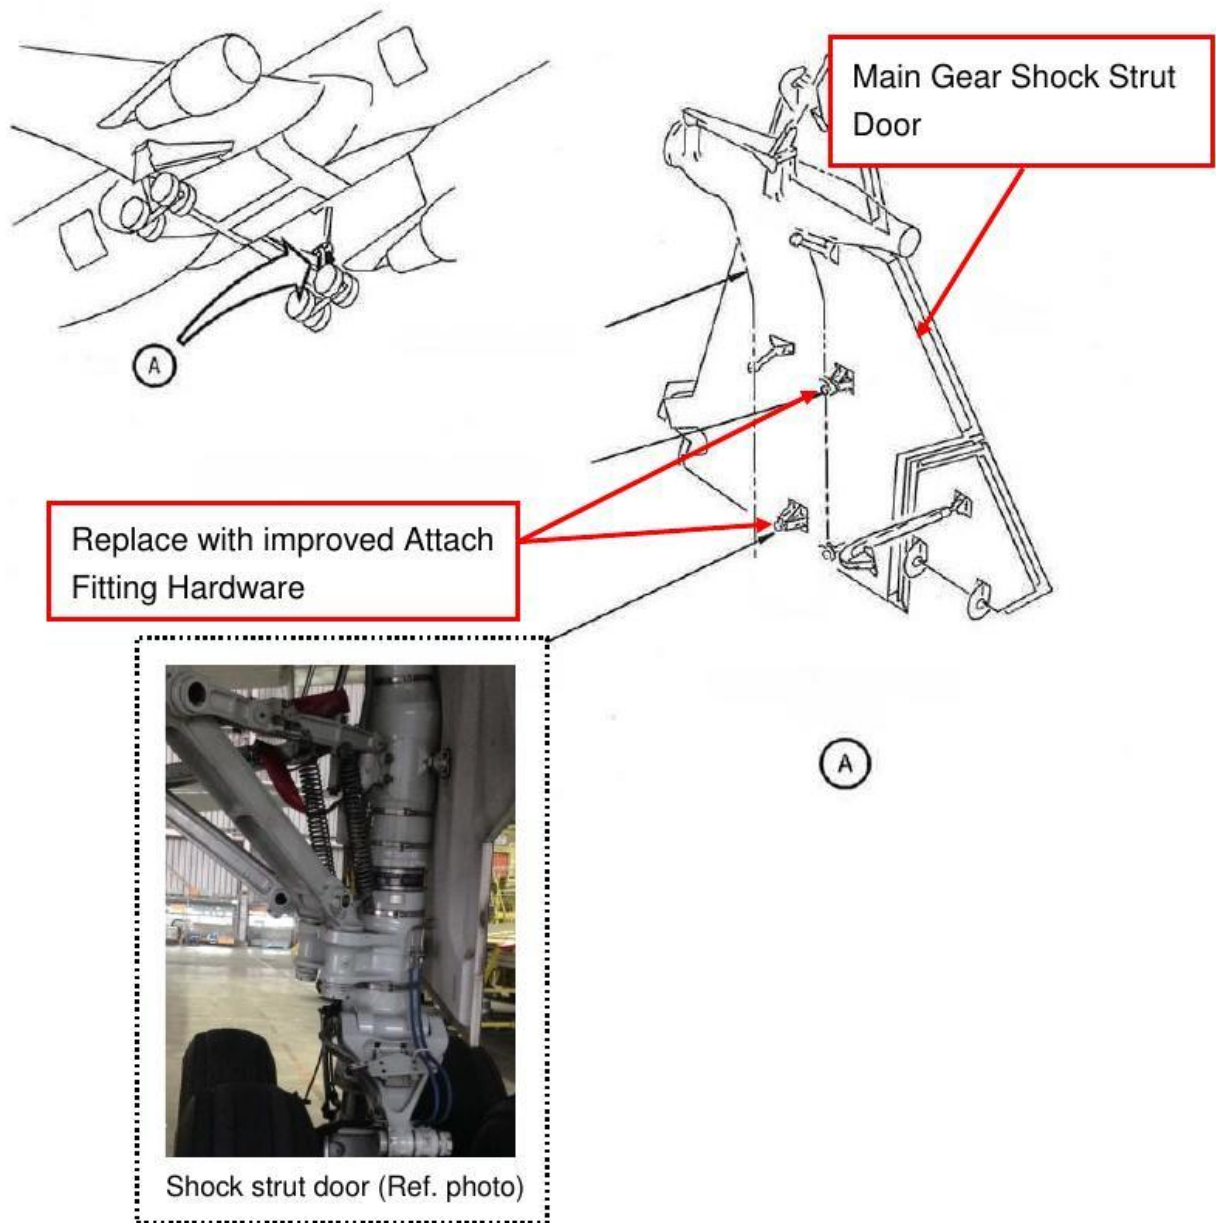
Fig. 1-8

Model	Title
B767	LANDING GEAR – Main Landing Gear and Doors – Main Gear Shock Strut Door and Linkage – Mid and Lower Attach Fitting Hardware Replacement (SB 767-32-0194)

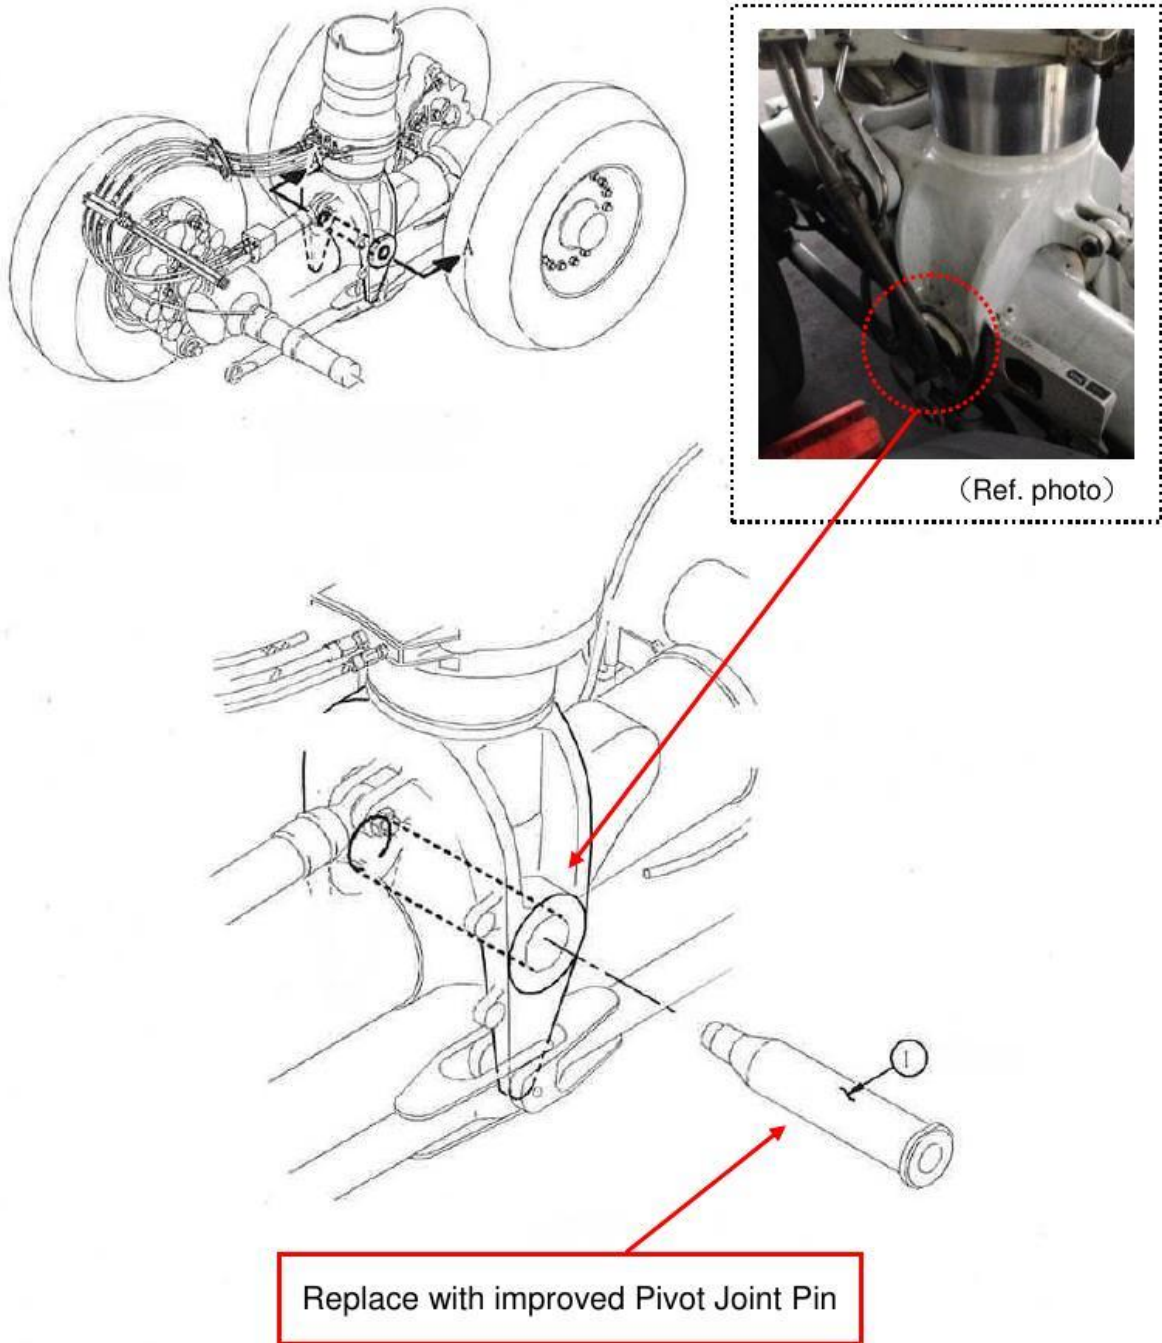
Fig. 1-9

Model	Title
B767	LANDING GEAR – Main Landing Gear Bogie Beam Pivot Joint Pin Replacement (SB 767-32A-0199)

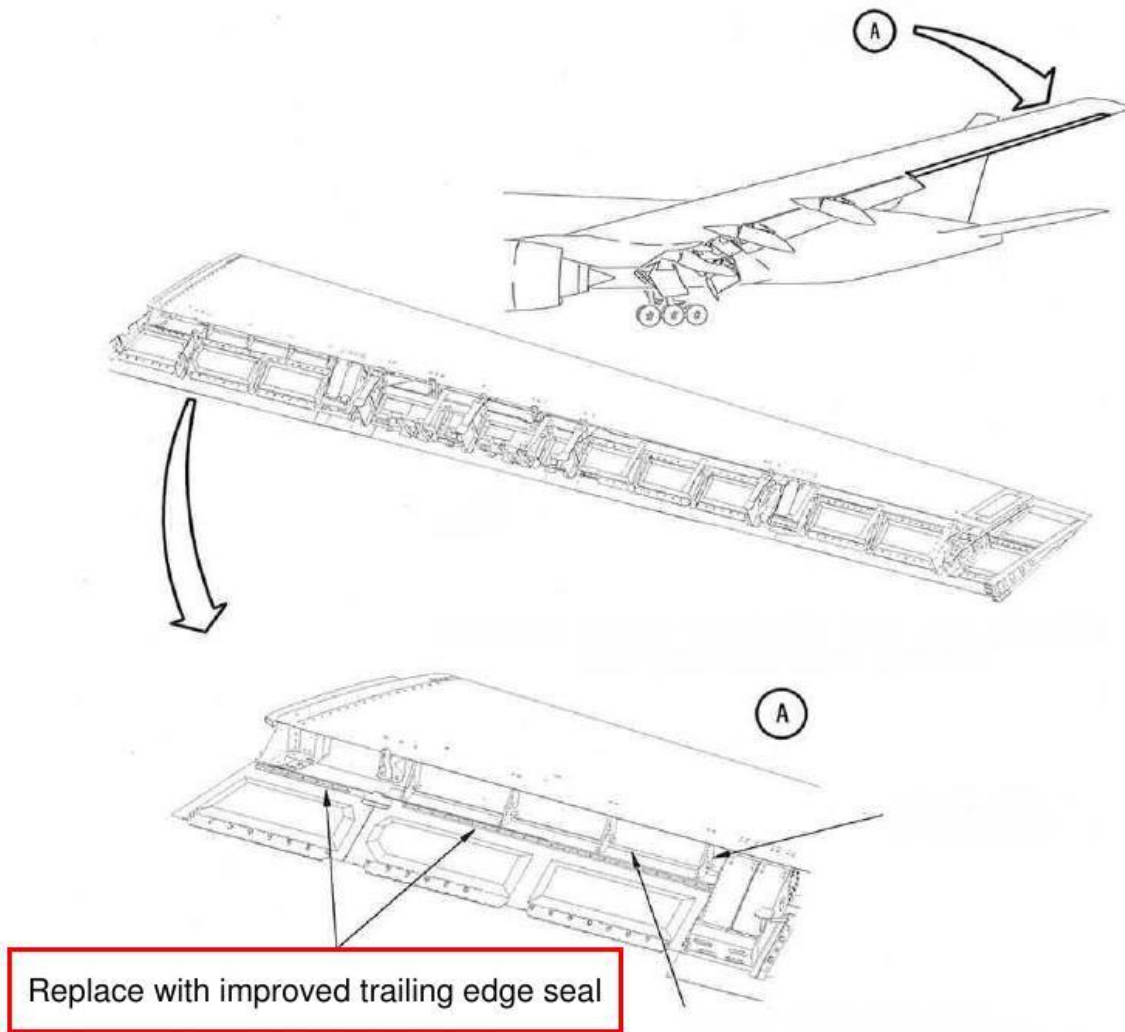
Fig. 1-10

Model	Title
B777	AILERONS AND FLAPERONS-Aileron Leading Edge Rib Addition And Fixed Trailing Edge Seal Replacement (SB 777-27-0022)

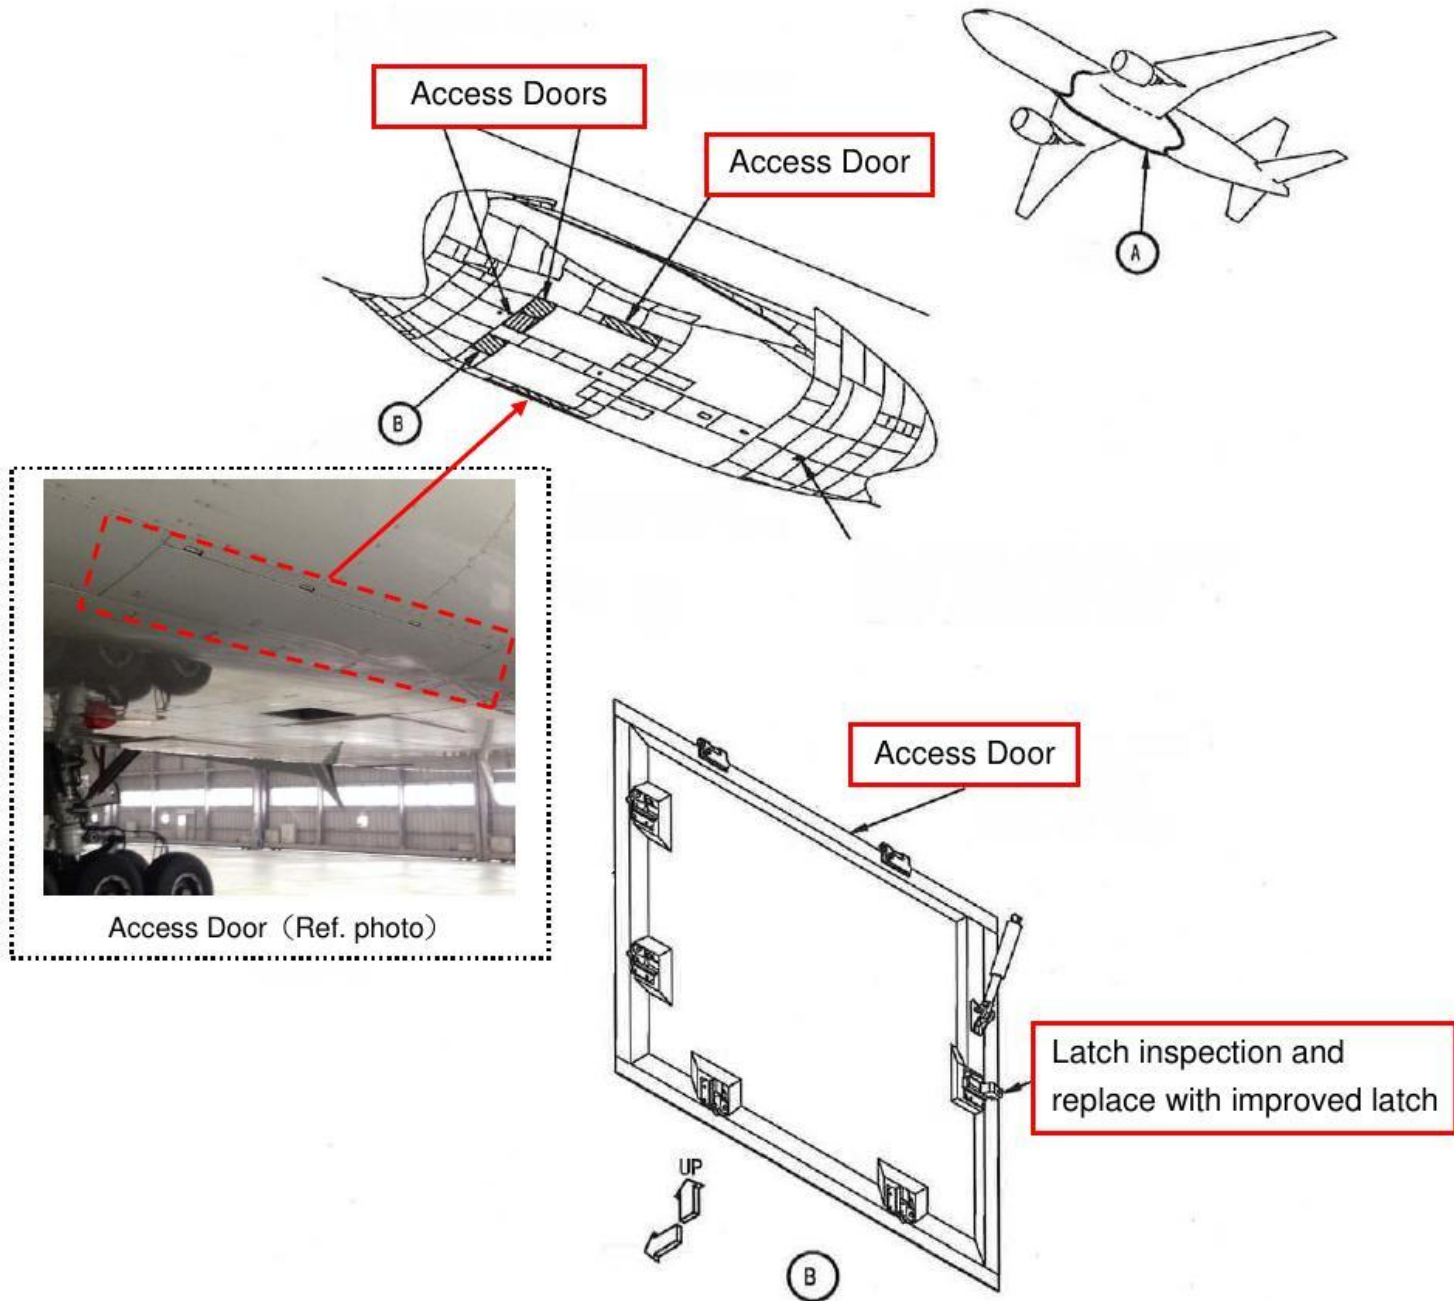
Fig. 1-11

Model	Title
B777	FUSELAGE - Section 44 - Aerodynamic Fairings - Underwing Fairing Access Doors - Rigging and Latch Replacement (SB 777-53-0050)

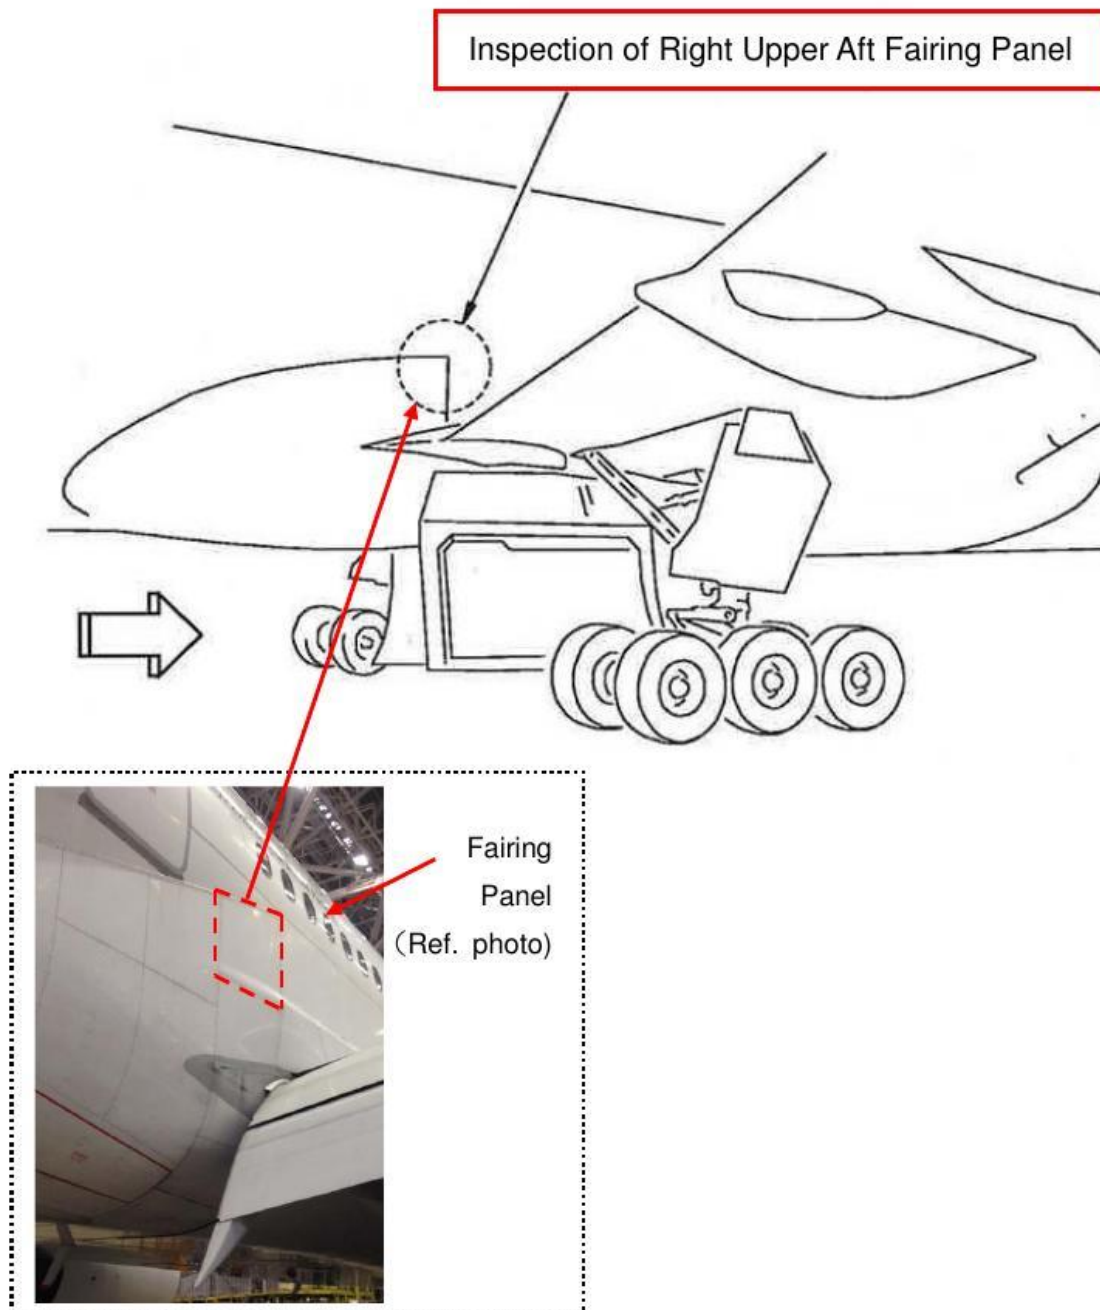
Fig. 1-12

Model	Title
B777	FUSELAGE - Aerodynamic Fairings - Right Upper Aft Fairing Panel Assembly Misfair Inspection/Replacement (SB 777-53-0056)

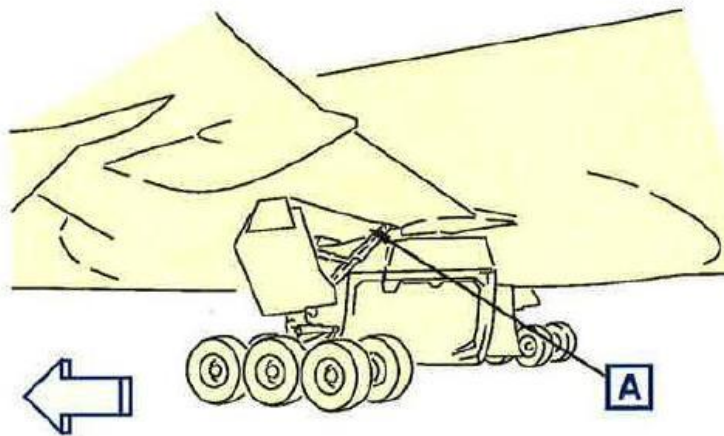
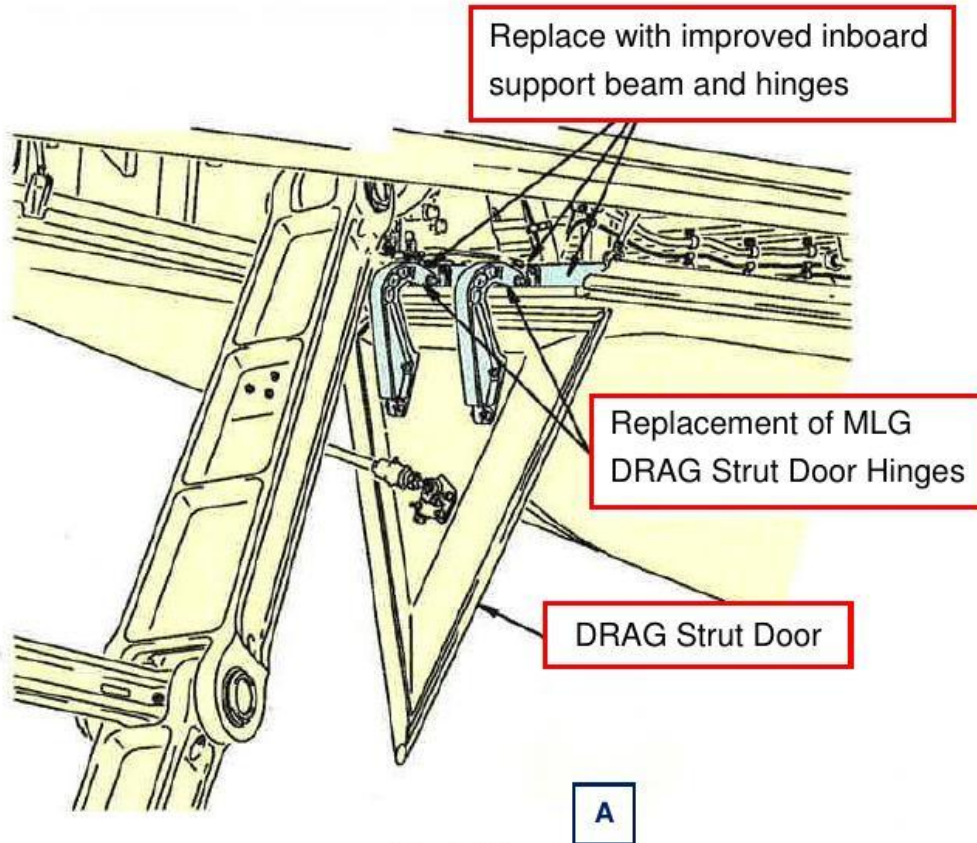
Fig. 1-13

Model	Contents of Measure
B777	WINGS - Wing Trailing Edge - Inboard Fixed Trailing Edge Support Beam Replacement (SB 777-57-0093)

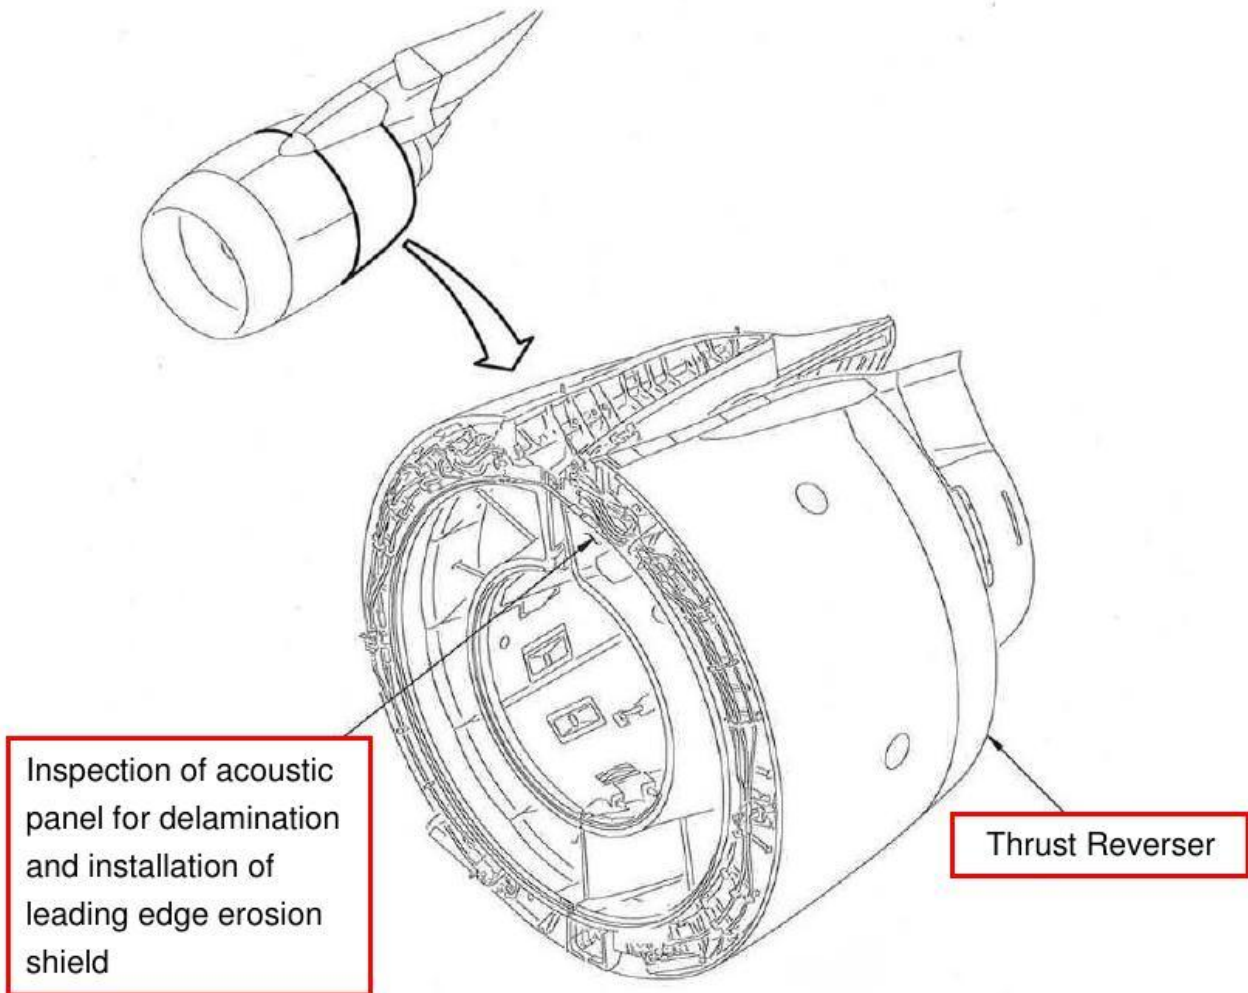
Fig. 1-14

Model	Title
B777	POWER PLANT (PW4000) - EXHAUST - THRUST REVERSER - UPPER BIFURCATION EROSION SHIELD – ADDITION (SB 777-78-0022)
