Implementation of Measures to Prevent Objects Falling off Airplanes

January 2018

Civil Aviation Bureau of Japan,
Ministry of Land, Infrastructure, Transport and Tourism
Association of Air Transport Engineering and Research

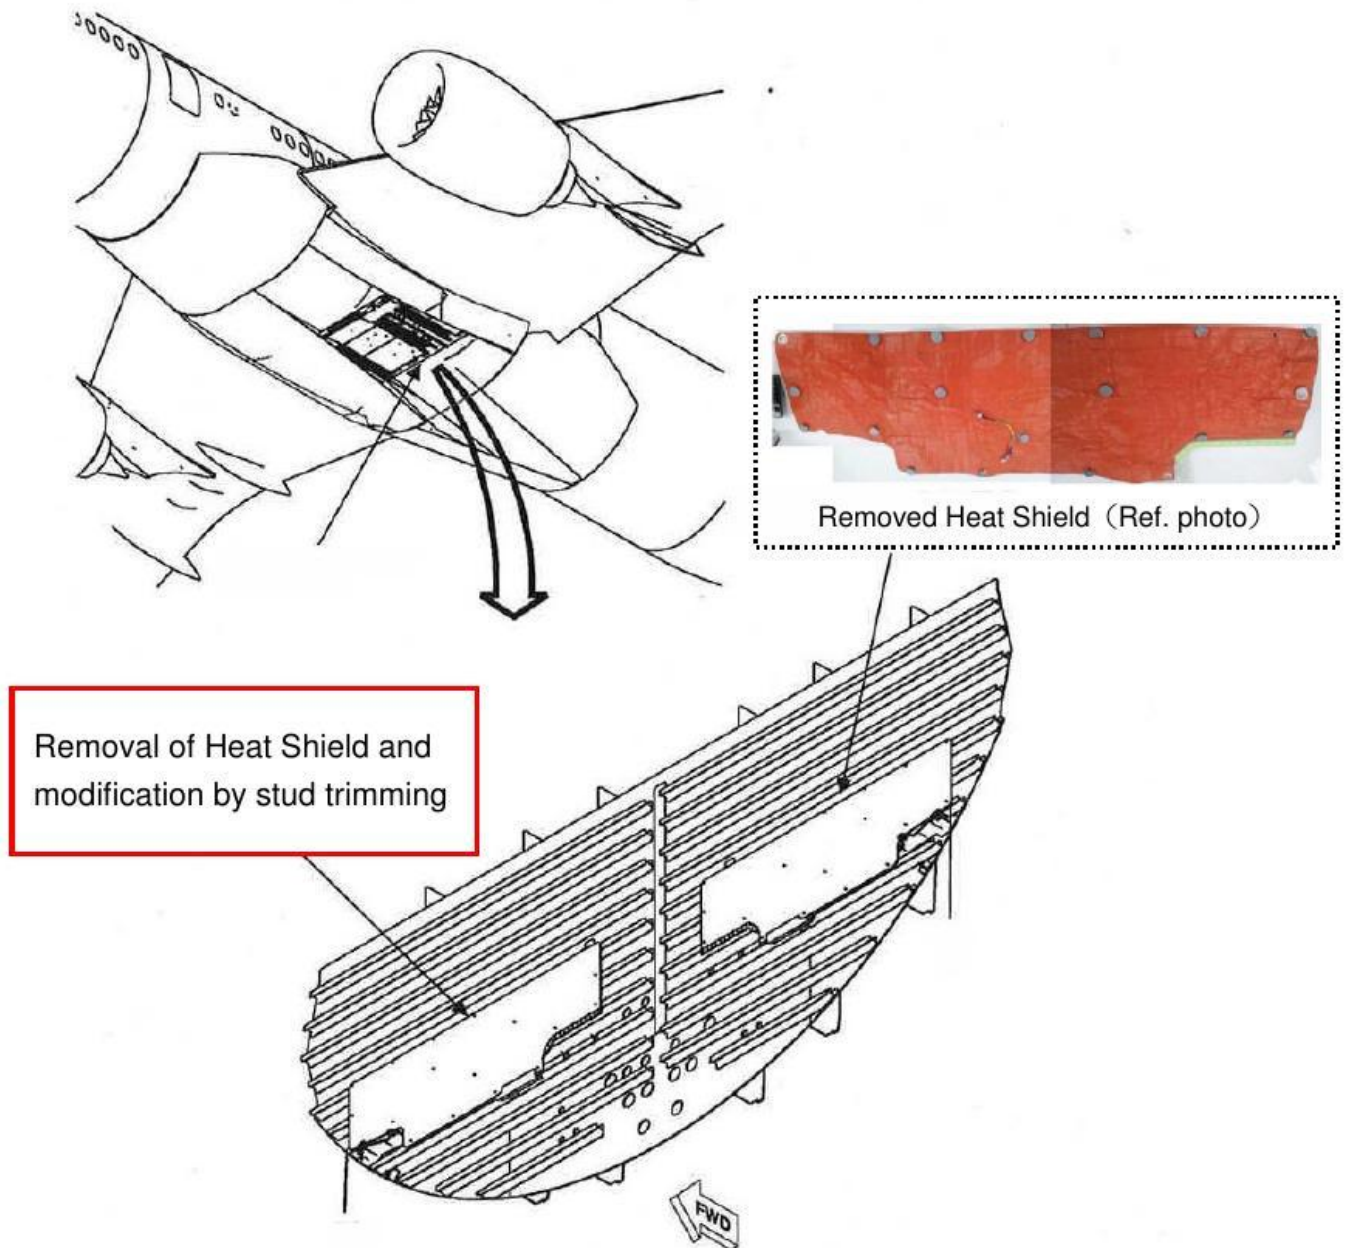
Fig. 1-15

Model	Title
B787	FUSELAGE - Main Landing Gear Wheel Well Structure – Section45 – Aft Wheel Well Bulkhead Heat Shield Click Bond Revision (SB 787-53-0022)

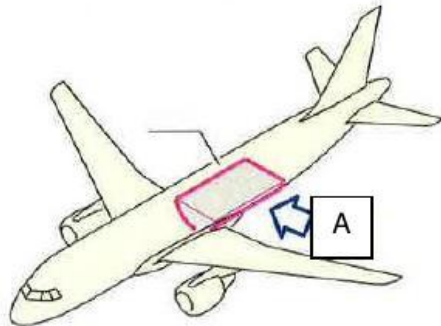
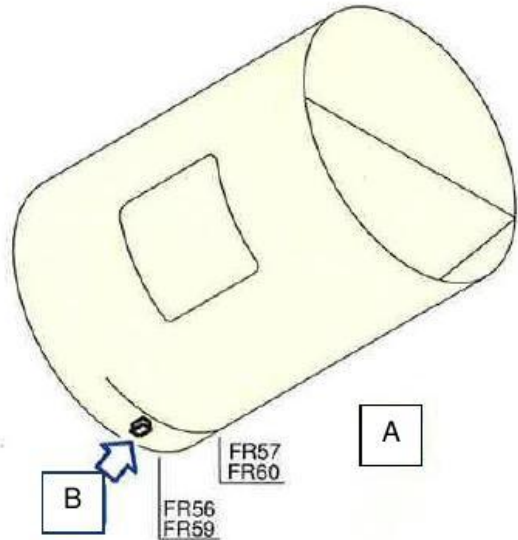
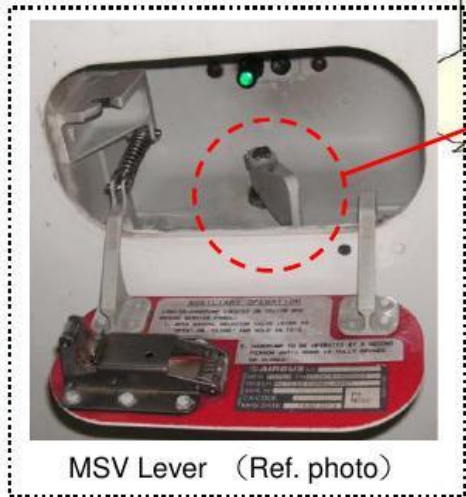
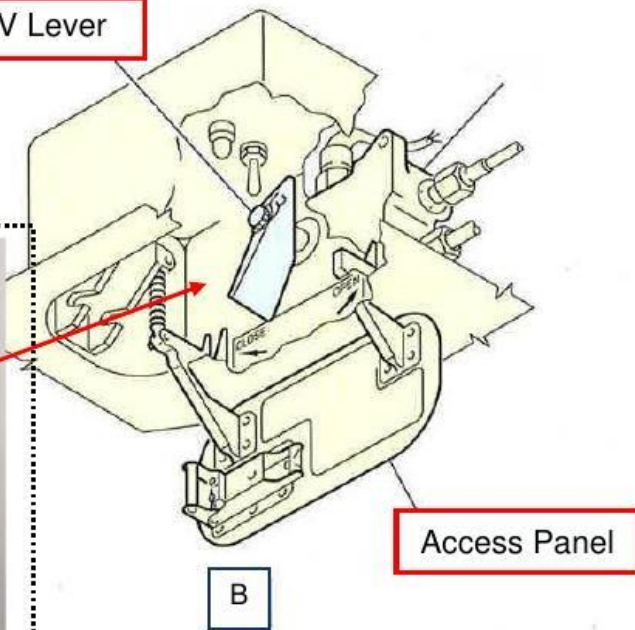
Fig. 2-1

Model	Title
A320	DOORS – CARGO COMPT DOOR HYD SYSTEM – IMPROVE LOCKING AND INTERFACE TOLERANCE OF MANUAL SELECTOR VALVE (MSV) LEVER (SB A320-52-1160)

Replace with improved MSV Lever

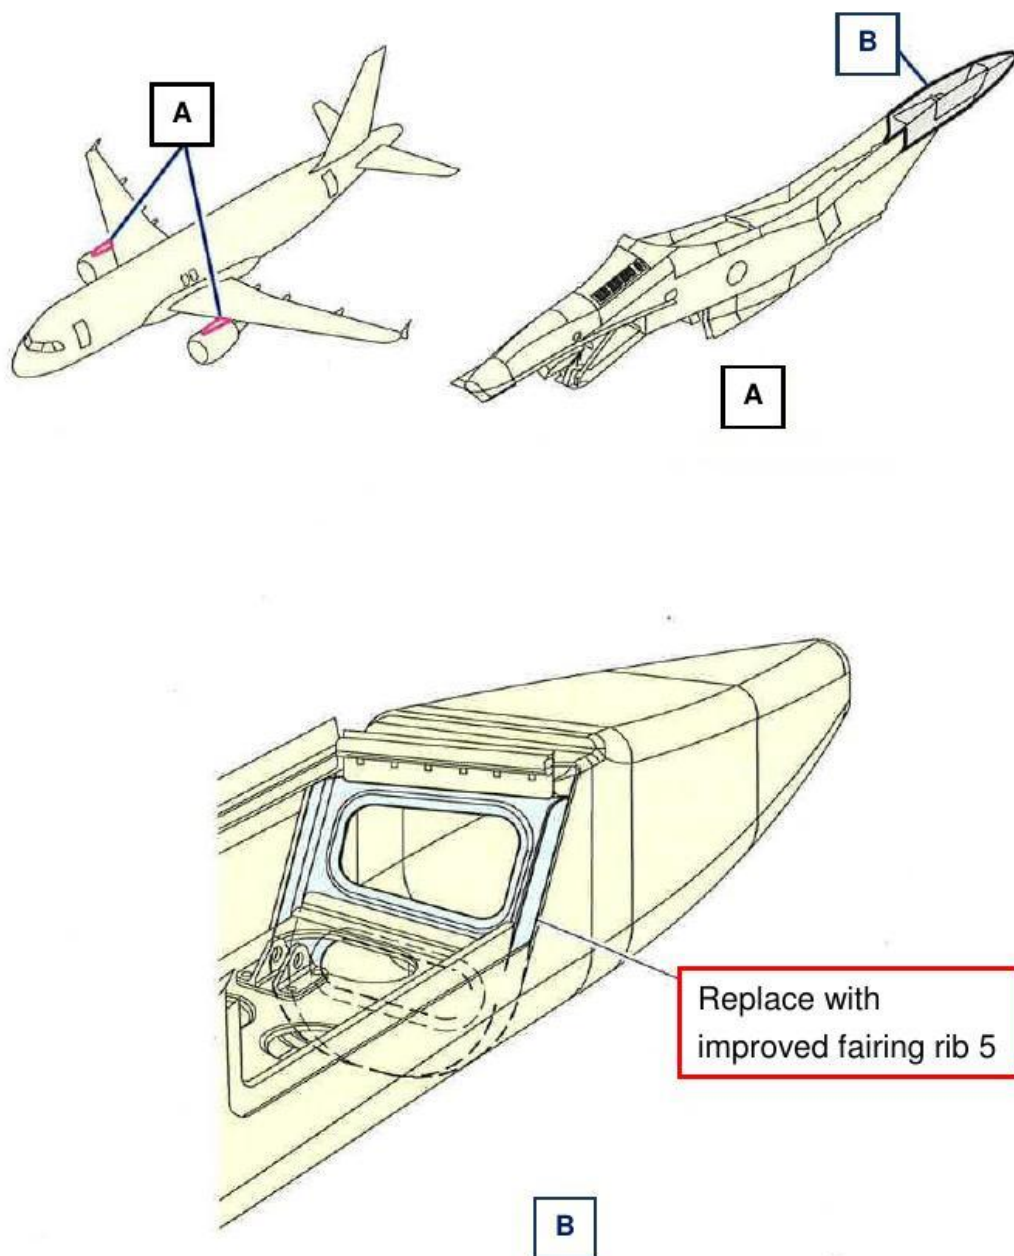
Fig. 2-2

Model	Title
A320	NACELLE & PYLON – AFT MOVABLE FAIRING – RIB 5 RE-DESIGN (SB A320-54-1028)

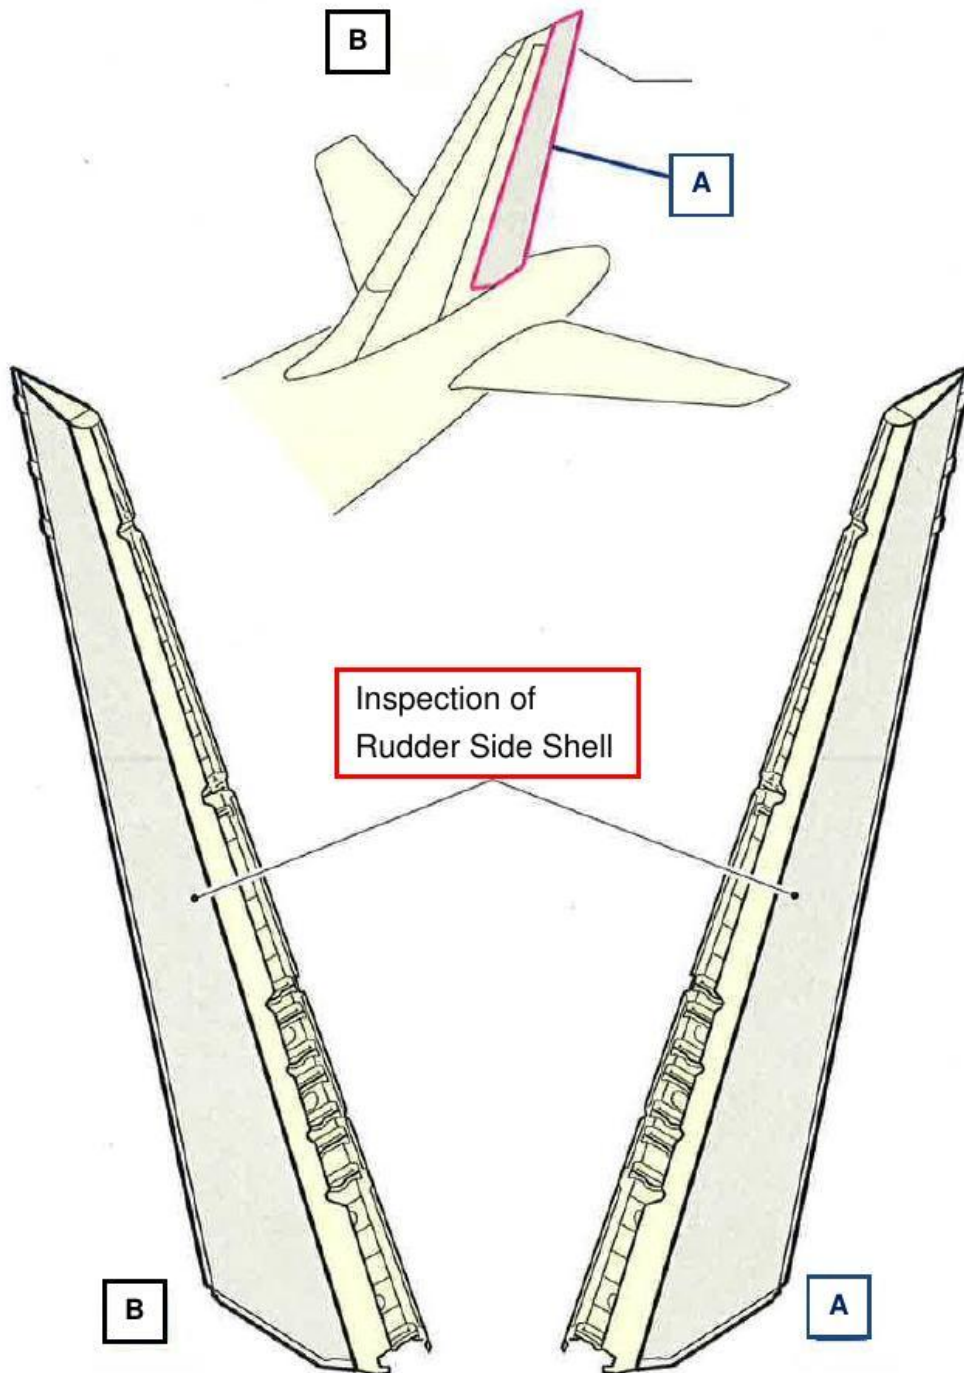
Fig. 2-3

Model	Title
A320	STABILIZERS - RUDDER SIDE SHELL SANDWICH REPAIR INSPECTION (SB A320-55-1041)

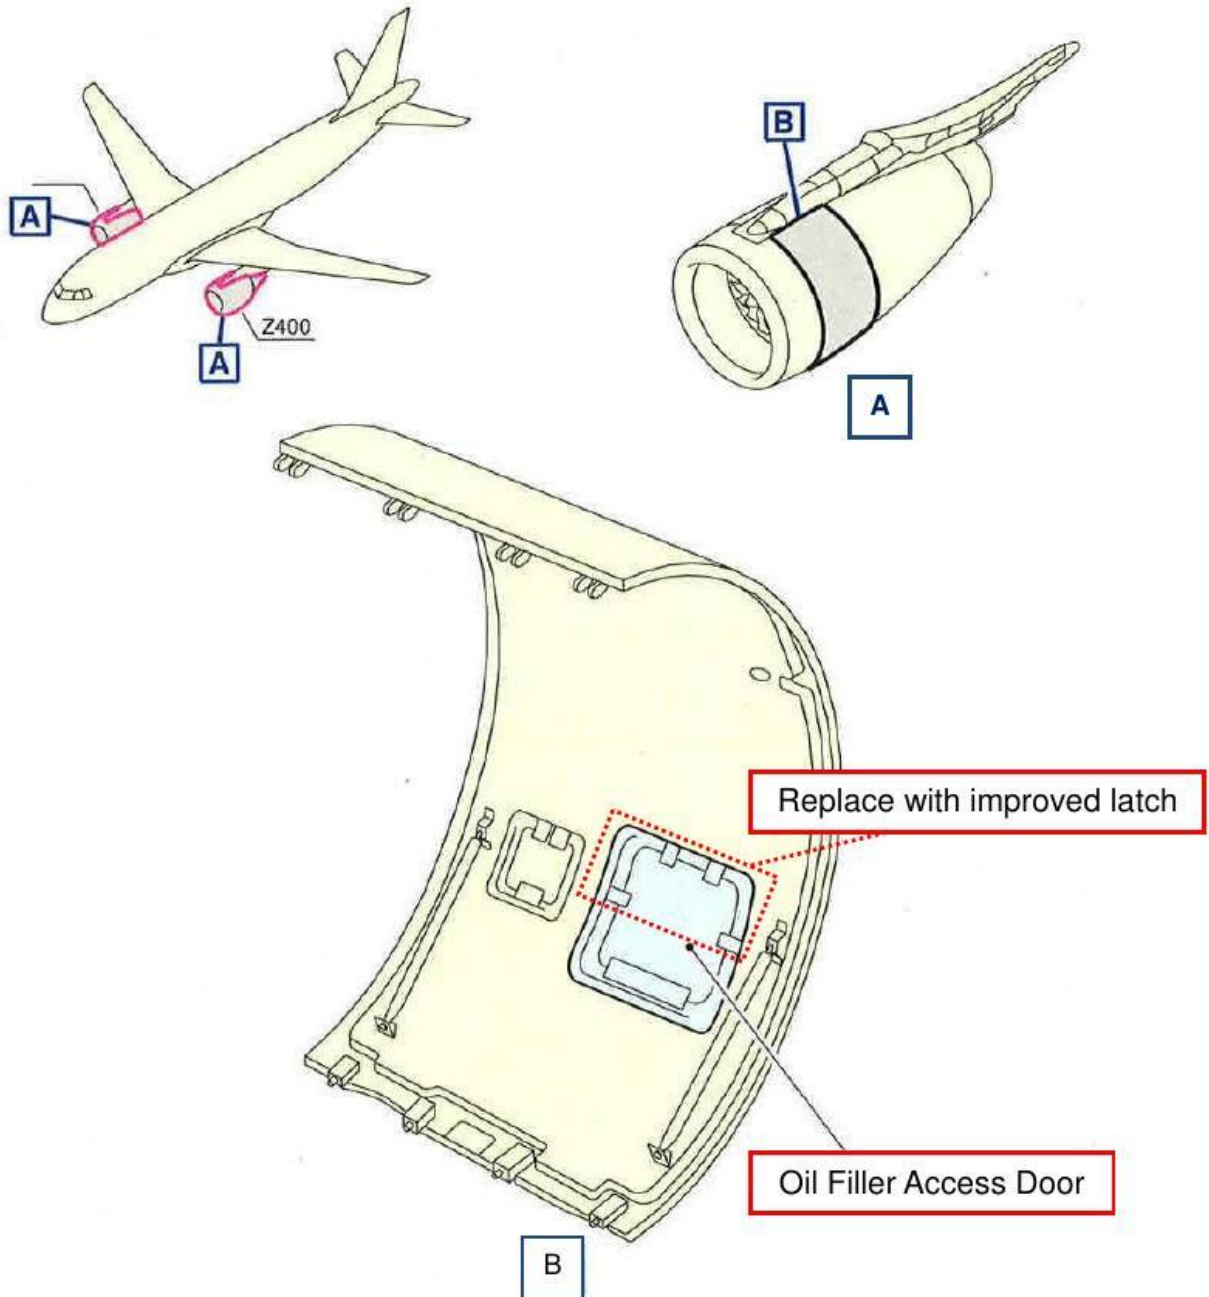
Fig. 2-4

Model	Title
A320	POWER PLANT - FAN COWL DOORS - INTRODUCE AN IMPROVED OIL FILLER DOOR LATCH DESIGN ON IAE ENGINE (SB A320-71-1061)

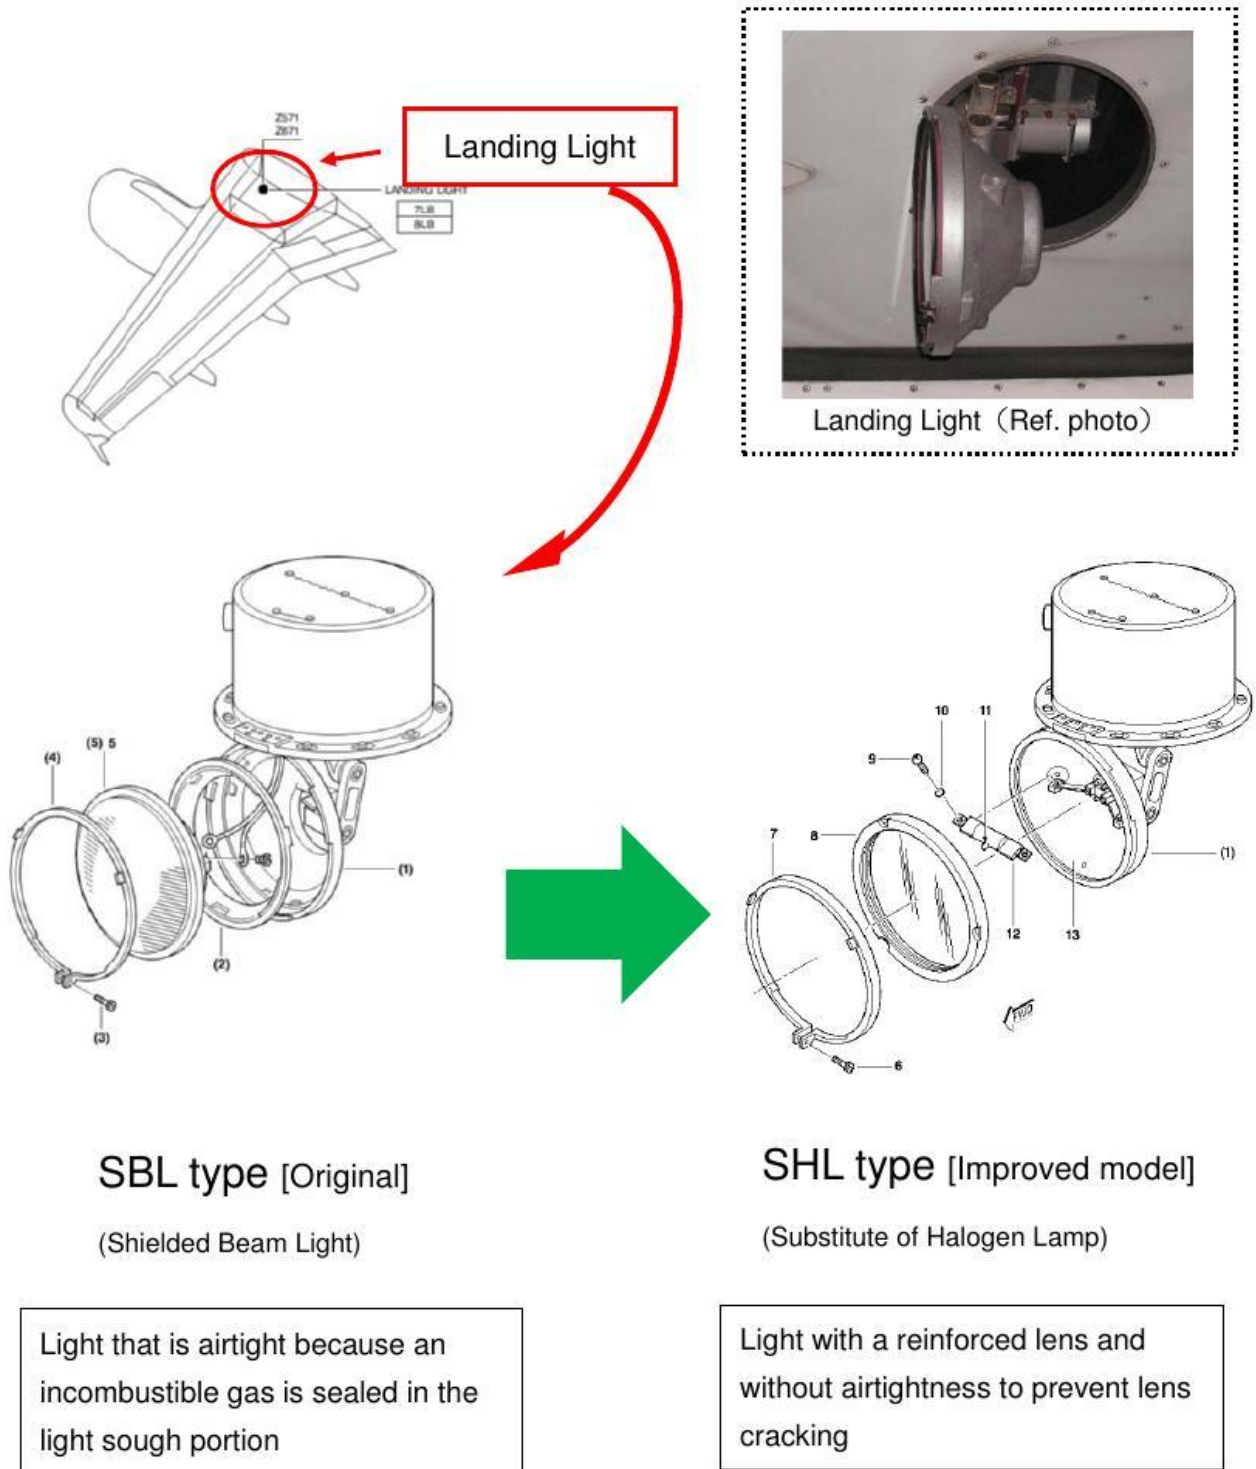
Fig. 2-5

Model	Title
A320	APPLY SHL TECHNOLOGY ON LANDING LIGHTS (TFU33.42.00.004)

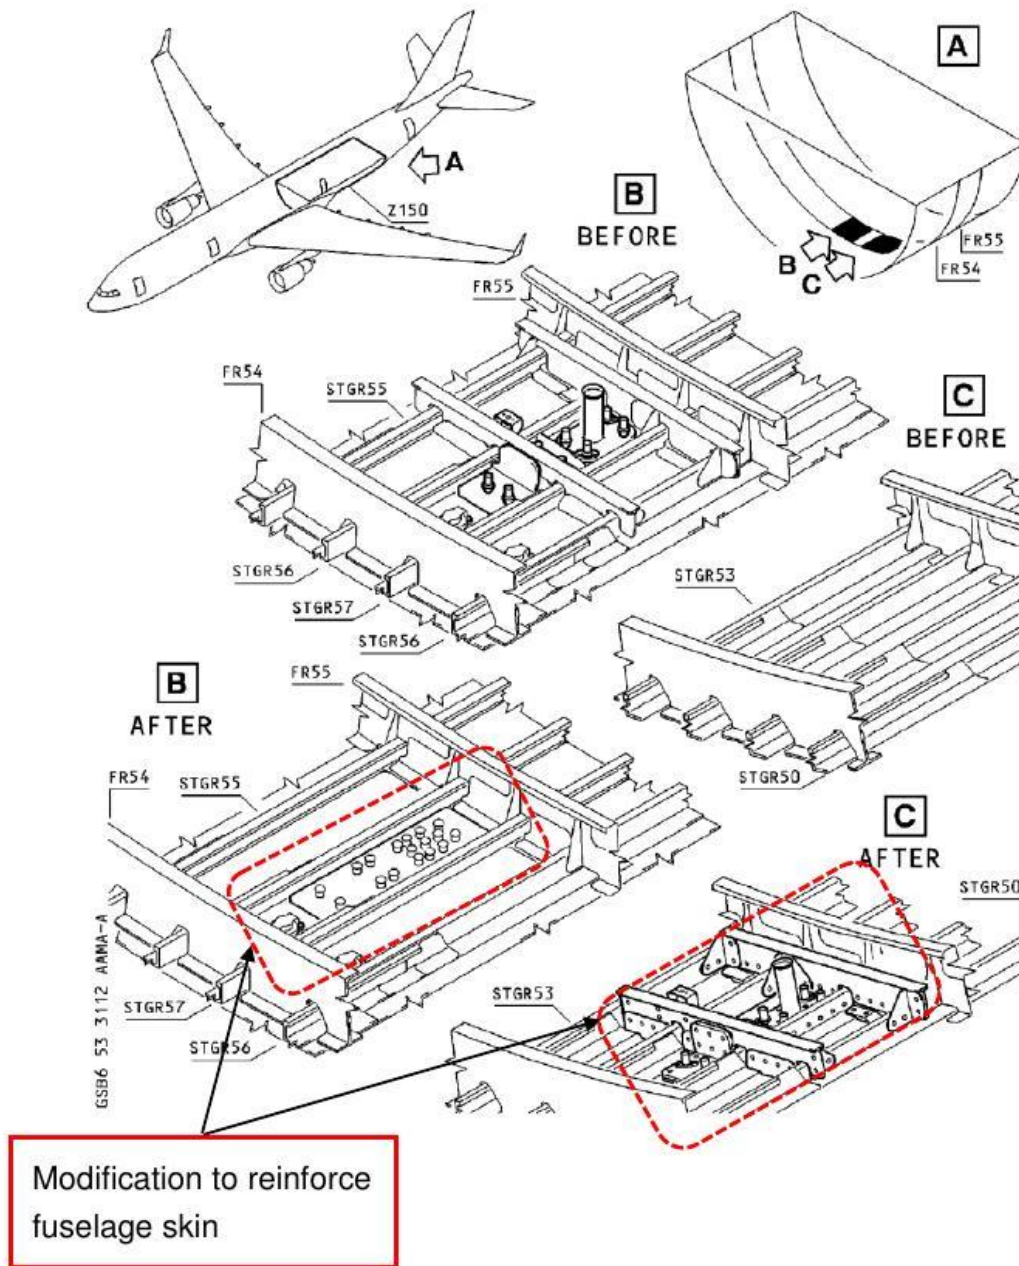
Fig. 2-6

Model	Title
A330	FUSELAGE – REAR FUSELAGE – RELOCATE VHF 2 ANTENNA (SB A330-53-3112)

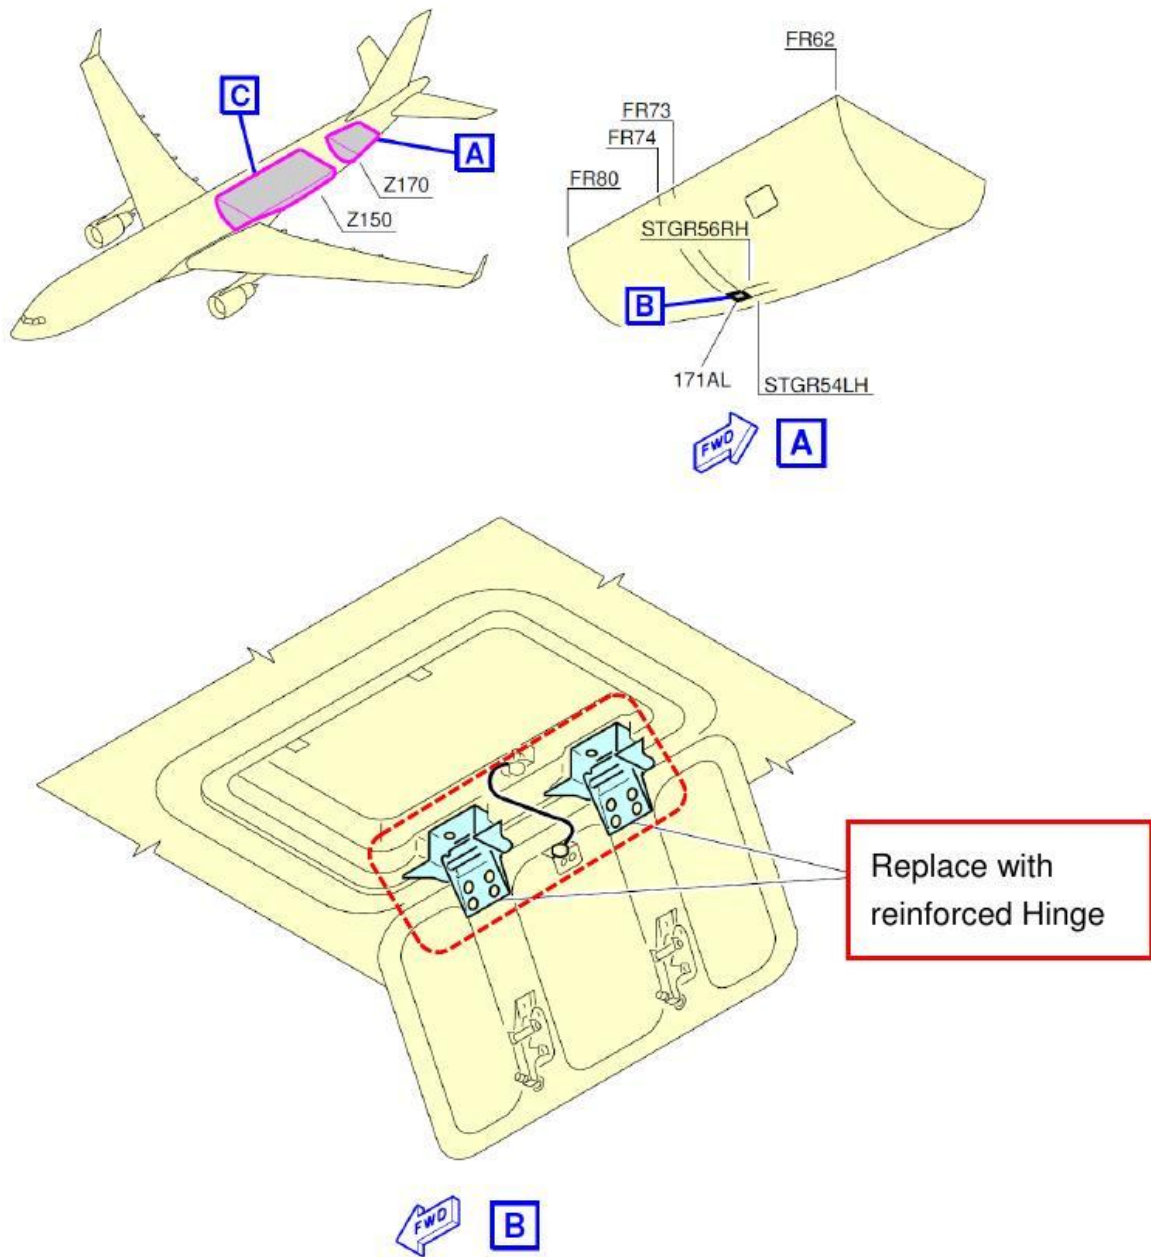
Fig. 2-7

Model	Title
A330	DOORS – SERVICE DOORS – IMPROVE SERVICE PANEL ACCESS DOORS IN SECTION 16 AND 18 (SB A330-52-3108)

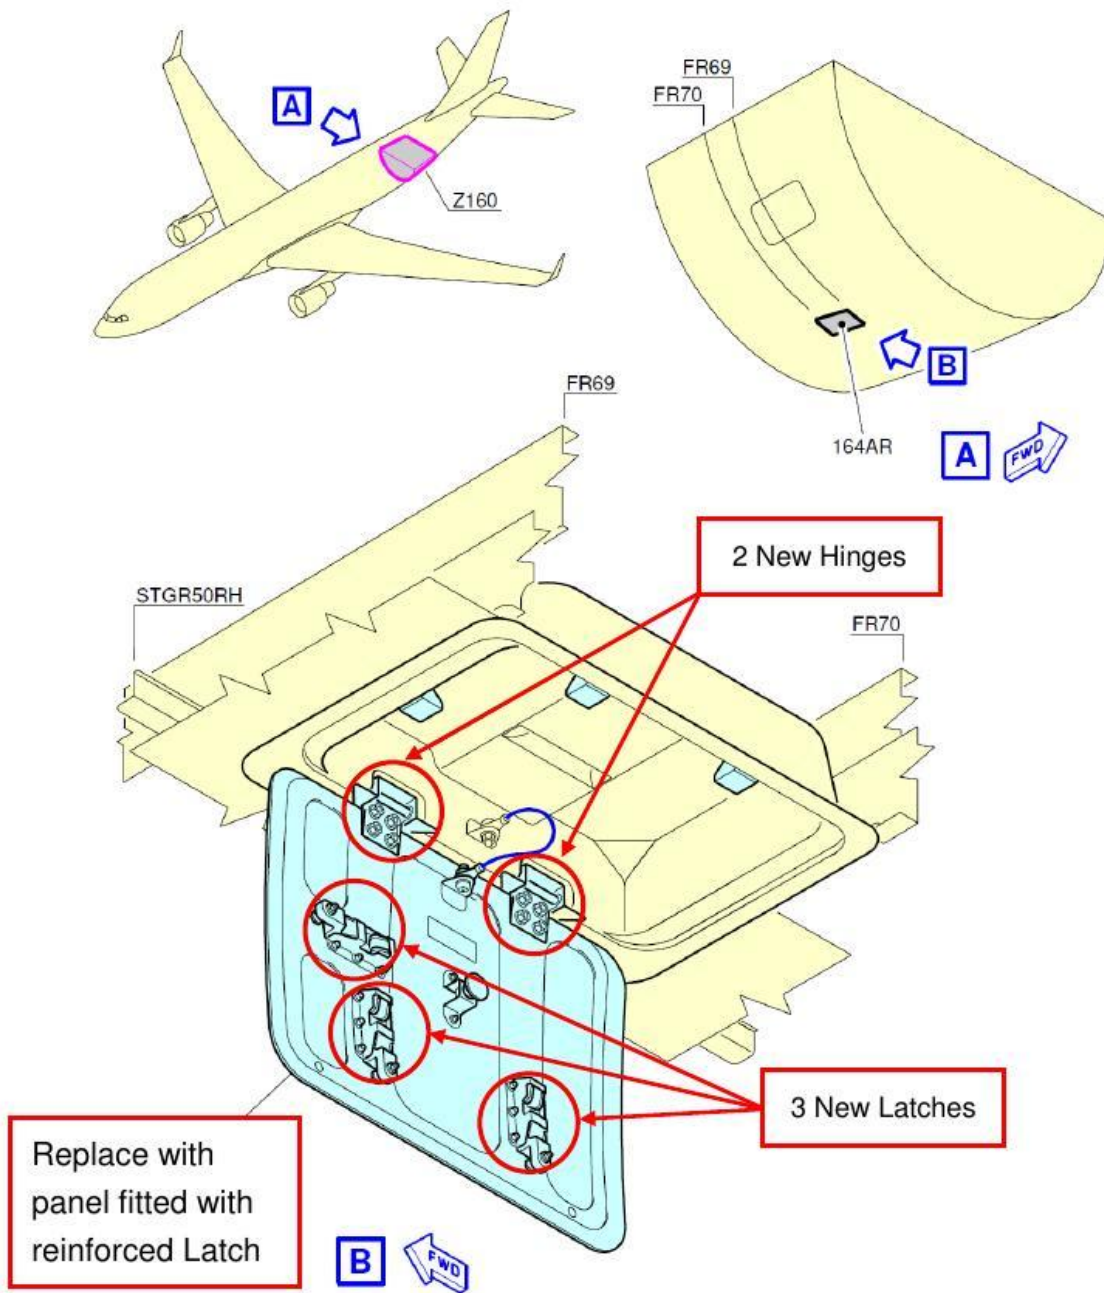
Fig. 2-8

Model	Title
A330	DOORS - SERVICE DOORS-MODIFICATION OF LATCHING MECHANISM OF POTABLE WATER SERVICE PANEL (SB A330-52-3086)
